PROPERTY REPORT

Property Name: 33 Maplewood Avenue

Survey Name: Cranbury CLG Survey 2017

Organization: RGA, Inc.

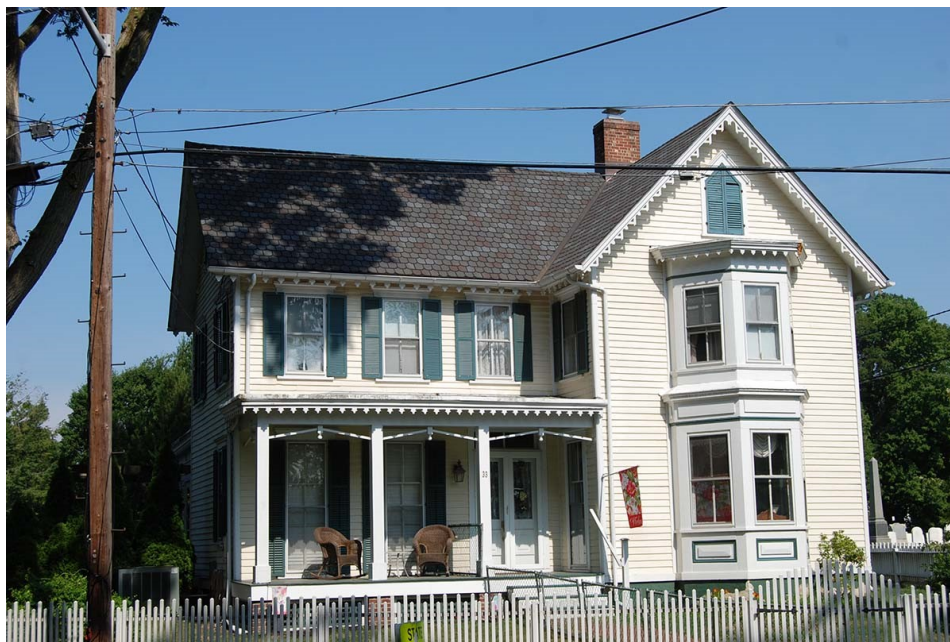
Property Photo:

33 Maplewood Avenue is a two-and-a-half-story tall, four-bay wide, two-bay deep, frame private residence constructed circa 1860 in a Carpenter Gothic style with a front gable and wing plan. The dwelling has a one-story, one-bay, shed-roof frame addition to the northwest, added to the dwelling by 1916. The cross-gabled roof is sheathed with slate shingles. An interior brick chimney pierces the roof at the intersection of the ridgelines. The exterior of the dwelling is clad in wood clapboard siding on all elevations. Fenestration on the front (southeast) elevation of the wing consists of two-over-two, double-hung, potentially original wood-sash windows with louvered shutters and molded wood lintels. Windows on the first floor also feature double-hung wood walkout windows. A pointed millwork frieze board runs above the windows on the second floor, below the eaves. A pointed window with louvered shutters punctuates the peak of the front gable. A pointed millwork vergeboard accentuates the front gable end. A two-story, semi-hexagonal projecting bay is centered beneath the pointed window. The projecting bay contains three two-over-two, double-hung, potentially original wood-sash windows on both floors, with molded rectangular panels framing the windows on the bay's first floor. A pointed millwork frieze board, similar to that on the second floor of the wing, runs above the windows on the bay's second floor.
