PROPERTY REPORT

Property Name: 57 South Main Street
Address: 57 S MAIN ST

Survey Name: Cranbury Local Historic District Survey 2018

Organization: Paulus, Sokolowski & Sartor

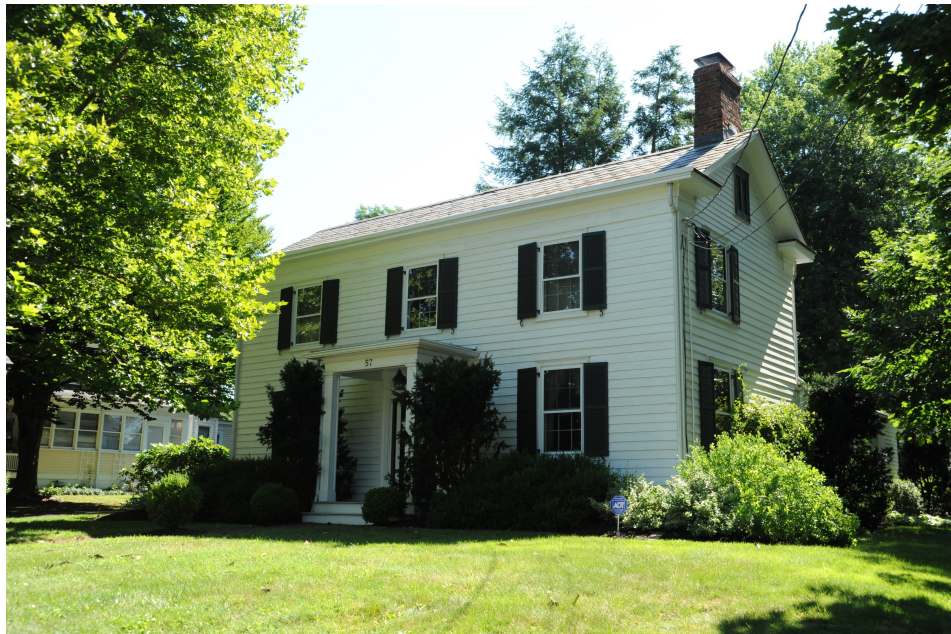
Property Photo:

The 2-story, side gable-roofed, T-plan main block of this clapboard-clad residence on a parged foundation is 3 bays wide and 2 bays deep and is fronted on the west by a 1-story, 1-bay, centered porch and backed on the east by a 2-story, partial-width volume that is in turn flanked on the southwest by a 1-story, partially enclosed porch that wraps around the east elevation. A 2-story, gable-roofed side volume projects from the northeast corner of the main block. The roofs are predominantly clad in asphalt shingle. An interior, brick, ridge chimney is located near the south end of the main block. The windows predominantly have 6/6, double-hung, historic wood sash with historic louvered shutters. The front porch includes replaced square-plan posts with recessed panels. The primary entrance, accessed by the porch, includes a historic, 9-light storm door and a historic paneled door. The historic door surround includes narrow, single-light sidelights a narrow, single-light transom. The remaining bays of both floors are regularly fenestrated. The south, side elevation is only partially visible from the public right-of-way and is lighted in the main block by 2 windows and in the rear volume by 2 6-light casement windows on the first floor and 2 windows on the second floor. The east bay of the porch is enclosed with clapboard siding. The north, side elevation is regularly fenestrated except for a single window on the second floor of the main block. A shuttered window opening is on the third floor of both side elevations. The east, rear elevation is not visible from the public right-of-way. The 1 ½-story, frame, gable-roofed garage is only

partially visible from the public right-of-way and is clad in wood shingle.

57 S. Main Street is a contributing property to the Cranbury Historic District because it retains integrity and historic, character-defining features such as the historic massing and fenestration patterns of its main volume, historic windows, historic shutters, historic wood door, and historic brick chimney.
