PROPERTY REPORT

Property Name: 53 South Main Street
Address: 53 S MAIN ST

Survey Name: Cranbury Local Historic District Survey 2018

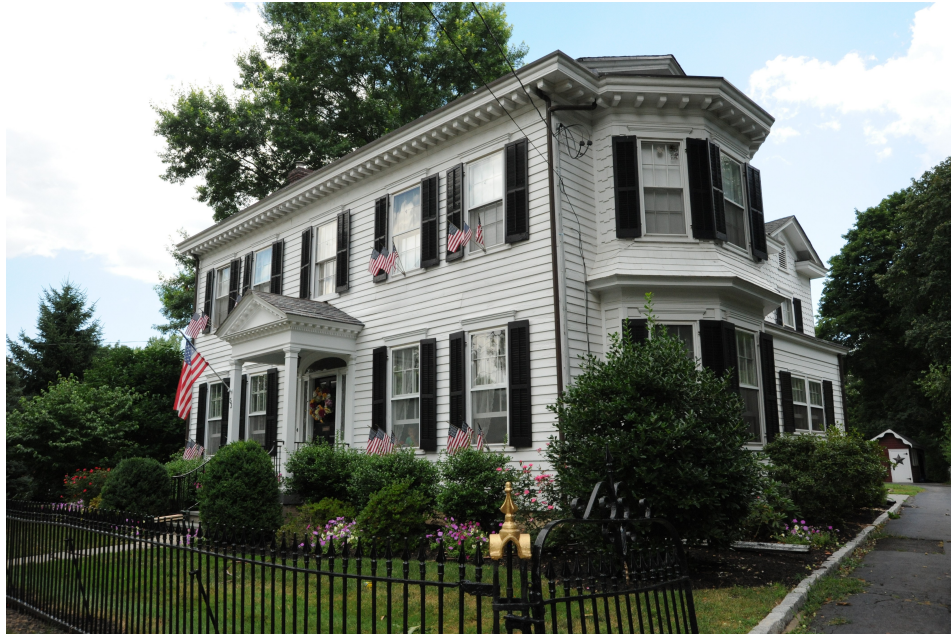
Property Photo:

The 2-story, side gable-roofed, rectangular-plan main block of this clapboard-clad, frame residence on a brick foundation is 5 bays wide and 2 bays deep and is fronted on the northwest by a 1-story, 1-bay, pedimented, central porch and backed on the southeast by a 2-story, gable-roofed, L-plan volume that is in turned flanked on the southwest by a 1-story, composite-roofed volume. A 2-story, hip-roofed, 3-sided bay projects from the southwest elevation of the main volume. A 1-story, hip-roofed historic addition is located on the northeast end of the main volume. The roofs of the front porch and main volume are articulated by a dentilled cornices. The roofs are predominantly clad in asphalt shingle except for the front porch and side volume, which are clad in slate tile. An interior, brick, ridge chimney is located near the northeast end of the main block. The windows predominantly have 6/6, historic wood sash with historic louvered shutters. The front porch, accessed by a flared stone and concrete stair with wrought iron rails, includes historic replacement square-plan posts, a simple frieze, and a cornice with both small and large dentils. The primary entrance, located in the central bay of the northwest elevation, includes a historic door surround with leaded glass sidelights over recessed panels and a segmental arch, leaded glass transom. The remaining bays of both floors are regularly fenestrated. The southwest, side elevation is regularly fenestrated. A painted wood shingle-clad pent eave

divides the first and second floors of the southwest bay. The upper floor of the projecting bay and the upper floor of the southeast bay of the rear volume are clad in painted wood shingles of alternating lengths. The northeast, side elevation is lighted on both floors of the main block by a single window and on the front and side elevations of the side volume by 8/8 wood sash windows. The southeast, side elevation is not visible from the public right-of-way. The 2-story, gable-roofed, clapboard-clad barn is located to the east of the residence and includes scalloped bargeboard and historic shuttered openings. The 1-story, asymmetrical gable-roofed, clapboard-clad shed, located to the southeast of the residence, also includes scalloped bargeboards and a historic, simple door.

The residence at 53 S. Main Street contributes to the Cranbury Historic District because it retains integrity and historic, character-defining features such as its historic window sash, historic fenestration patterns, historic clapboard and shingle cladding, historic replacement door, surround and replacement door, and historic wrought iron rail. The barn and shed retain their historic massing, historic openings, and historic surface materials.
