## PROPERTY REPORT

**Property Name:** 59 South Main Street

**Survey Name:** Cranbury Historic Sites Survey Phase III

**Organization:** Richard Grubb & Associates, Inc.

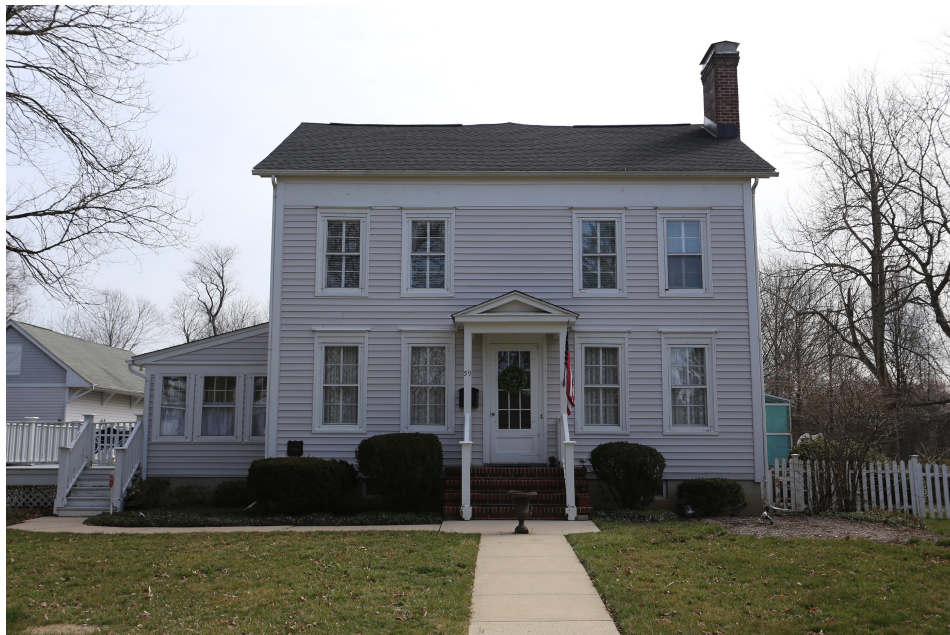
### Property Photo:

59 South Main Street is a two-and-one-half-story-tall, five-bay-wide, two-bay-deep, frame dwelling built in 1826 in the Greek Revival style. It consists of a side-gabled main block with a one-story, shed-roof addition to the north (added circa 1960) and a gable-roof, two-story-tall, four-bay-wide, two-bay-deep, rear (east) addition (added circa 1998). The rear addition features a two-story-tall, shed-roof projection on the north elevation and a one-story, glass-enclosed, solarium on the south elevation (added circa 1998). Replacement exterior brick chimneys extend above the south gable end of the main block and the rear gable end of the rear addition. The roof is sheathed in asphalt shingles. The exterior of the dwelling is clad in vinyl siding. The north and south elevations of the main block feature a molded wood cornice with paired brackets (historic, likely original). A wood frieze board extends across the primary (west) elevation of the main block (historic, likely original). Windows on the main block are primarily four-over-over, double-hung, wood-sash units, set within wood surrounds with wood storm windows (likely historic). The primary elevation of the main block has symmetrical fenestration with a central, primary entrance containing a glazed wood storm door (likely historic) beneath a pediment-font portico, supported by square wood posts. The entrance is accessed by a brick stoop. The north addition features single and grouped, six-over-one, double-hung, wood-sash units, set within wood surrounds with wood storm windows. A wood deck with simple wood balustrades lines the north elevation of the north addition. The rear addition has symmetrical fenestration, with one-over-one, vinyl-sash windows that feature arched transoms on the first floor and in the gable end. The dwelling stands on a concrete foundation featuring vinyl fixed-pane basement-level windows on the main block.

Character-defining elements of the dwelling include its massing, bracketed cornice, wood frieze, and wood-sash windows.
