PROPERTY REPORT

Property Name: George Nafee House
Address: 49 S MAIN ST

Survey Name: Cranbury Local Historic District Survey 2018

Organization: Paulus, Sokolowski & Sartor

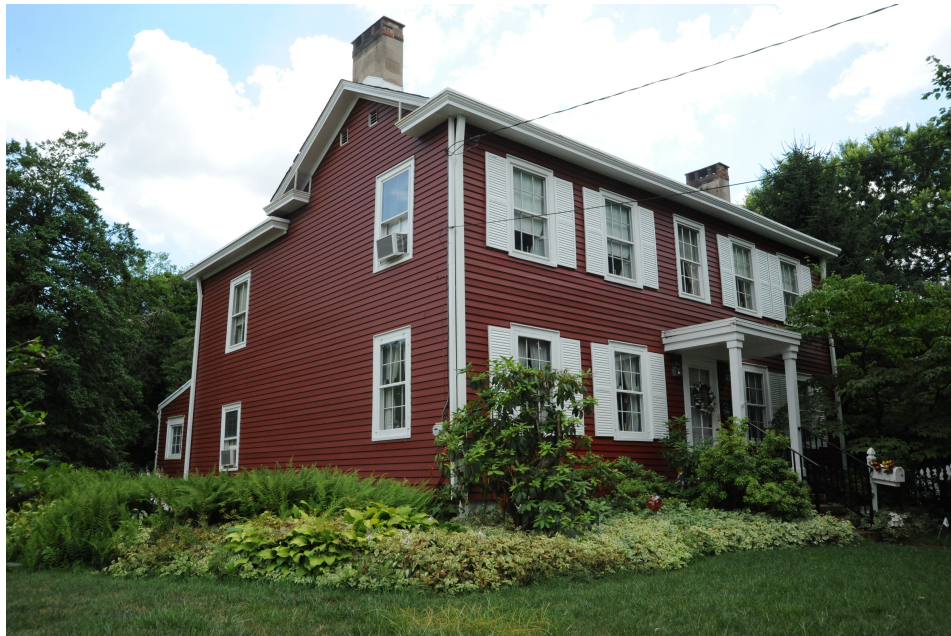
Property Photo:

The 2-story, side gable-roofed, rectangular-plan main block of this aluminum siding-clad, frame dwelling on a parged foundation is 5 bays wide and 2 bays deep and is fronted on the northwest by a 1-story, 1-bay, flat-roofed, centered porch and backed on the southeast by a 2-story, composite-roofed, full-width secondary volume. The rear volume is in turn backed by a 1-story, shed-roofed, full-width rear el. Interior, stuccoed, brick, ridge chimneys are located near the southwest and northeast ends of the main volume. The windows predominantly have 6/6, double-hung, historic wood sash in the main volume and 2/2, historic wood sash in the rear volume. The front porch is accessed by a straight brick stair with wrought iron rail and includes replacement square-plan posts with a simple cornice. The primary entrance, accessed by the porch, includes a historic door with recessed panels and a historic replacement 8-light storm door. The remaining bays of both floors are regularly fenestrated with applied shutters on all but the central window of the second floor. The southwest, side elevation is regularly fenestrated and includes an enclosed recessed porch in the first floor of the rear volume, accessed by a door to the northwest and lighted by a bank of 8-light, casement windows to the southeast. The northeast, side elevation is regularly fenestrated and includes a fixed 9-light window in the rear el. The southeast, rear elevation is not visible from the public right-of-way. The historic 1-story, gable-roofed, vertical board-clad shed, located to the southeast

of the residence, includes exposed rafter tails and historic shed doors and shuttered openings.

The residence at 49 S. Main Street contributes to the Cranbury Historic District because it retains integrity and historic character-defining features such as its historic massing of the main and secondary volumes, historic fenestration patterns and wood windows, and historic door and storm door. The shed contributes to the historic district retains its historic massing, historic surface materials, and historic doors and openings.
