PROPERTY REPORT

Property Name: Henry Perrine House
Address: 47 S MAIN ST

PS&S recommends that 47 S. Main Street, constructed circa 1796 and extensively renovated circa 2015, is a contributing property in the Cranbury Historic District.

Survey Name: Cranbury Local Historic District Survey 2018

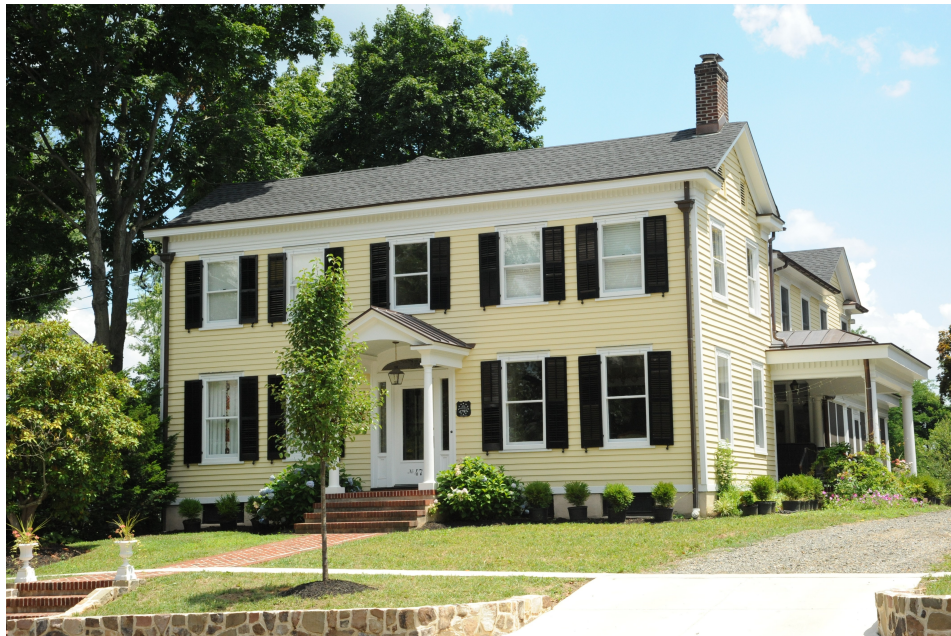
Property Photo:

The 2-story, side gable-roofed, rectangular-plan main block of this clapboard-clad, frame residence on a concrete foundation is 5 bays wide and 2 bays deep and is fronted by the elevation by a 1-story, gable-roofed, 1-bay centered entry porch and backed on the southeast by a 2-story, gable-roofed, full-width, 5 bay-deep, altered secondary volume. The rear volume matches the height of the main volume in the northwest bay and projects higher in the 4 southeast bays, with a gabled wall-dormer in the southeasternmost bay. A 1-story, hip-roofed, side porch projects from the northwest bay of the southwest side of the rear volume and extends beyond the southwest elevation of the main block. The remaining bays of the southwest elevation of the rear volume are flanked by a 1-story, shed-roofed, enclosed porch. The roofs are predominantly clad in asphalt shingle except for the porches, which are clad in standing-seam metal. The windows throughout have replacement frames and 1/1 replacement sash. The front porch includes Tuscan columns and a historic segmental arch under the gable that matches the fanlight over the door. An interior, brick, ridge chimney is located near the southwest elevation of the main volume. The historic door surround includes single-light sidelights over recessed panels and a segmental arch, leaded-glass fanlight. The remaining bays are regularly fenestrated on both floors. The southwest, side elevation is regularly fenestrated in both the main and rear volumes. A secondary entrance is accessed by the projecting side porch, with includes replacement columns and an added dentilled

cornice. The enclosed porch, accessed by a door in the central bay, is articulated by columns and lighted by large, single-light windows over recessed panels. The northeast, side and southeast, rear elevations are not visible from the public right-of-way.

47 S. Main Street is a contributing property to the Cranbury Historic District because it retains character-defining historic features such as the historic replacement door surround and historic chimney. However, the scale of volumes added in recent construction campaigns, the altered fenestration patterns, and the near-total replacement of windows and surface materials make this status extremely marginal.
