New Jersey Department of Environmental Protection Historic Preservation Office

PROPERTY REPORT

Property Name: Mary Groom House Address:

Survey Name: Cranbury Local Historic District Survey 2018

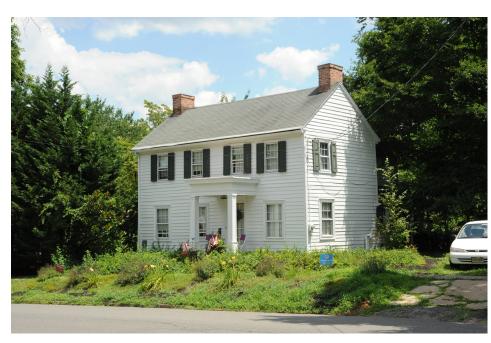
Property Photo:

The 2-story, side gable-roofed, rectangular-plan main block of this clapboard-clad, frame dwelling on a covered foundation is 4 bays wide and 2 bays deep and is fronted on the northwest, main elevation by a 1-story, 1-bay, flat-roofed porch and backed by a 2-story, gableroofed, partial-width secondary volume offset to the southwest that is flanked on the southeast by a 1-story, partially-enclosed porch that wraps around the rear of the secondary volume and flanked on the northeast by a lower, 1 1/2-story side volume that projects 1 bay beyond the main volume toward the northeast. The roofs are predominantly clad in asphalt single and the windows predominantly have 6/6 historic wood sash. Brick ridge chimneys are located near the gable ends of the main volume. The front porch includes replacement, square-plan posts with recessed panels modeled after the residence's historic posts and a historic entablature. The primary entrance to the residence, accessed by the front porch, includes a replacement 15-light door. The remaining bays of the elevation are regularly fenestrated with paneled shutters on the second floor windows. The northwest bay of the southwest elevation of the main block is lighted by a window on each floor. The rear volumes and the northeast, side elevations are not visible from the public right-of-way.

43 S. Main Street is a contributing property in the Cranbury Historic District because it retains integrity and such historic, character-defining features as its historic siding material, paneled wood shutters, wood window sash, and porch entablature.
