## PROPERTY REPORT

**Property Name:** 41 South Main Street

PS&S recommends that 41 S. Main Street, which includes a historic residence built circa 1850 and altered ca. 1900, and a garage built ca. 1920-1930, is a contributing property in the Cranbury Historic District.

**Survey Name:** Cranbury Local Historic District Survey 2018

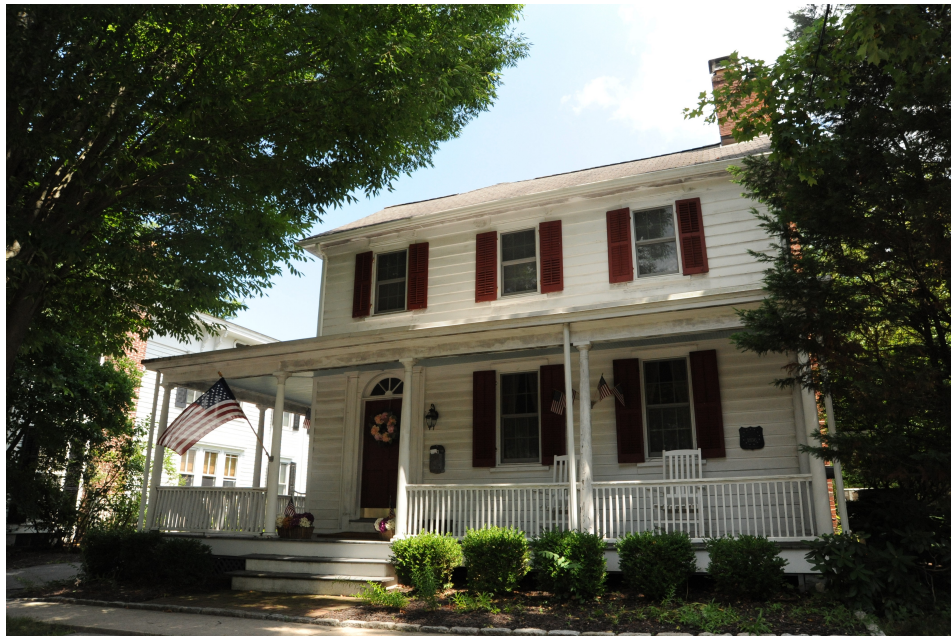
### Property Photo:

The 2 1/2-story, side gable-roofed, rectangular-plan main block of this clapboard-clad, frame dwelling on a brick foundation is 3 bays wide and 2 bays deep and is fronted on the northwest, main and northeast, side elevations by a 1-story, hip-roofed porch and backed on the southeast by a 2-story, cross gable-roofed secondary volume. The secondary volume is in turn backed by a 1-story, composite-roofed volume. The roofs are predominantly clad in asphalt shingle and the windows retain historic, double-hung, 6/1 wood window sash in most locations, and historic louvered wood shutters. An interior, double-stack, brick chimney projects from the southwest bay of the gable-ridge, backed by an exterior brick chimney that projects from the southwest, side elevation. An interior brick chimney also projects from the southwest roof slope of the rear volume. The front porch and main entrance are accessed by a stair in the northeast bay of the northwest elevation. A second stair is location in the southeast bay of the northeast elevation. The porch includes historic replacement columns and a historic replacement rail with square-plan balusters. The entrance includes a replaced door and historic, replacement, fluted pilaster surround with a 4-light fan light. The remaining bays are regularly fenestrated with decorative frieze panels above the second floor windows. The southwest, side and southeast, rear elevations are not visible from the public right-of-way. The northeast elevation is lighted by a single window on the first floor and a historic 6/6 sash window on the third floor of the main block. An entrance to the rear volume is

located on its northwest elevation, with a single window on the second floor. The northeast elevation of the rear volume is regularly fenestrated.

41 S. Main Street is a contributing property in the Cranbury Historic District because it retains its integrity and historic character-defining features such its historic replacement porch columns, historic replacement porch rail and balusters, historic door surround, historic wood windows in multiple locations, and historic massing and fenestration patterns of the main block.
