PROPERTY REPORT

Property Name: 39 South Main Street
Address: 39 S MAIN ST

Survey Name: Cranbury Local Historic District Survey 2018

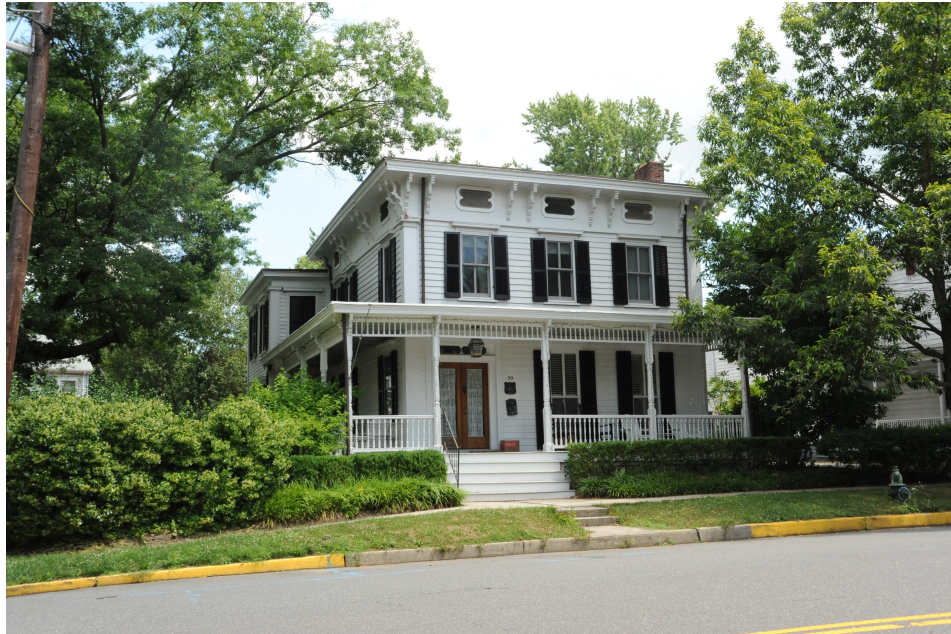
Property Photo:

The 2 1/2-story, hip-roofed, rectangular-plan main block of this clapboard-clad, frame dwelling on a painted brick foundation is 3 bays wide and 2 bays deep and is fronted on the northwest, main and northeast, side elevations by a 1-story, composite-roofed, wrap-around porch and backed on the northeast bays of the southeast elevation by a 2-story, composite-roofed rear volume offset to the northeast and projecting 1 bay beyond the main block. A 2-story, hipped-roof, rectangular-plan addition also backs the main volume on the southeast, offset to the southwest, with a flanking, 1-story, shed-roofed volume at the rear of its northeast elevation. An exterior brick chimney projects from the northwest bay of the southwest, side elevation. The roofs are predominantly composite-roofed and the windows predominantly have 2/2, double-hung historic wood sash with historic louvered shutters and historic entablatures with a projecting cornice. The roofs of the main volume and hip-roofed rear volume include a wide wood frieze with paired, scroll brackets and double elliptical-ended windows in the bays of the front elevation and in the outer bays of the side elevations. The corners of all volumes include full-height, Tuscan pilasters. The front porch includes historic turned posts, a historic rail with historic turned balusters, a historic spindle frieze, and historic scroll brackets. The porch is accessed by a straight stair in the northeast bay of the northwest elevation and the southeast bay of the northeast elevation. The primary entrance, located in the northeast bay of the northwest elevation, includes a historic door surround

with projecting cornice, a historic replacement (early 20th century), double-leaf door with large single, fixed lights, and a historic, 2-light transom with quarter-round corners. The remaining bays of the elevation are regularly fenestrated with full-height windows on the first floor. The third floor is lighted in each bay by a double elliptical-ended fixed window. The southwest, side elevation is asymmetrically fenestrated and includes a triple window on the first floor of the southeast bay of the main block. The rear volumes are regularly fenestrated, with an elliptical window in the northwest bay and a double window in the southeast bay of the first floor. The northeast, side elevation is regularly fenestrated with 2 windows on each floor of the southeast bay of the main block. A secondary entrance in the projecting northwest elevation provides access to the rear volume. The northeast, rear elevations of the rear volumes are only partially visible from the public right of way and include a pent eave and shaped shingle cladding on the 3-sided projecting bay of the northeast volume and a recessed entry in the 1-story, shed-roofed bay of the southwest volume. The 2-story, gable-roofed, vertical board-clad, frame carriage house is only partially visible from the public right-of-way and includes a historic shuttered second floor opening with wide hinges on the northwest elevation.

The residence at 39 S. Main Street is a key-contributing property in the Cranbury Historic District because it retains integrity, and key character-defining features such as the historic clapboard siding, historic shutters, historic 2/2 window sash, historic window entablatures with projecting cornices, historic double-leaf doors, historic door surround with historic transom lights, historic corner pilasters, historic wood frieze, historic brackets, historic third floor windows, and historic porch details including the historic turned posts, historic rail, historic turned balusters, historic spindle frieze, and historic brackets. The garage retains its historic vertical board siding and shutters.
