## PROPERTY REPORT

**Property Name:** Old Potato Farmhouse  
**Address:** 1-3 CRANBURY NECK RD

**Survey Name:** Cranbury Local Historic District Survey 2018

**Organization:** Paulus, Sokolowski & Sartor

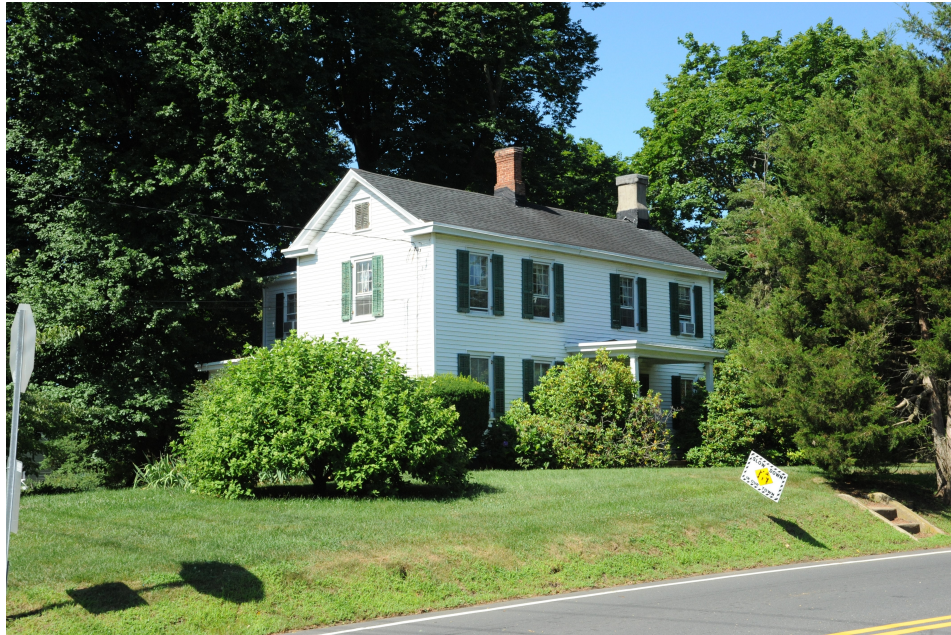
### Property Photo:

The 2-story, side gable-roofed, vinyl siding-clad main block of this frame dwelling on a concrete foundation is 5 bays wide and 2 bays deep, and is fronted on the northeast by a roughly centered, 1-story, hip-roofed entry porch and backed on the southwest by a 2-story, gabled rear volume. This is flanked on the southeast by a 1-story, composite-roofed side porch and flanked on the northwest by a 1-story side, shed-roofed porch that is partially recessed under the secondary volume. A 1-story, shed-roofed side volume flanks the main volume on the northwest. The roofs of the main volume and 1-story side volume are clad in asphalt shingle with cornice returns at the gable ends. A brick, interior, ridge chimneys is located near the center of the main roof and a stuccoed ridge chimney is near the northwest end of the main volume. The windows throughout include historic, louvered shutters and contain historic wood sash in 9/6 and 2/2 configuration. The front porch, on a brick and concrete base, includes historic, square-plan wood posts. The main entrance includes a 2-light, historic door. Each of the four flanking bays have a window on both floors, with the 9/6 sash on the second floor and 2/2 sash on the first floor. The northwest, side elevation is only partially visible from the public right-of-way and is fenestrated on the second floor of the main block by a

9/6 window in the northeast bay. The second floor of the rear volume is fenestrated in 2 6/6 or 6/1 windows. The side volume is lighted by a single window. The southeast, side porch includes replaced, historicized posts, balusters, and trim. The main volume is lit by 1 roughly centered window per floor with a 9/6 over a 2/2. The rear volume windows are 2/2. The side entrance, in the northeast bay of the rear volume, is located in the northeastern bay. The southwest elevation, only partially visible from the public right-of-way, includes 2/2 windows. In the secondary volume.

This property is a contributing property in the district because it retains integrity and historic, character-defining features such as its historic massing and fenestration patterns, historic wood window sash, historic porches, and historic chimneys.
