PROPERTY REPORT

Property Name: 5 Cranbury Neck Road

Survey Name: Cranbury Historic Sites Survey Phase III

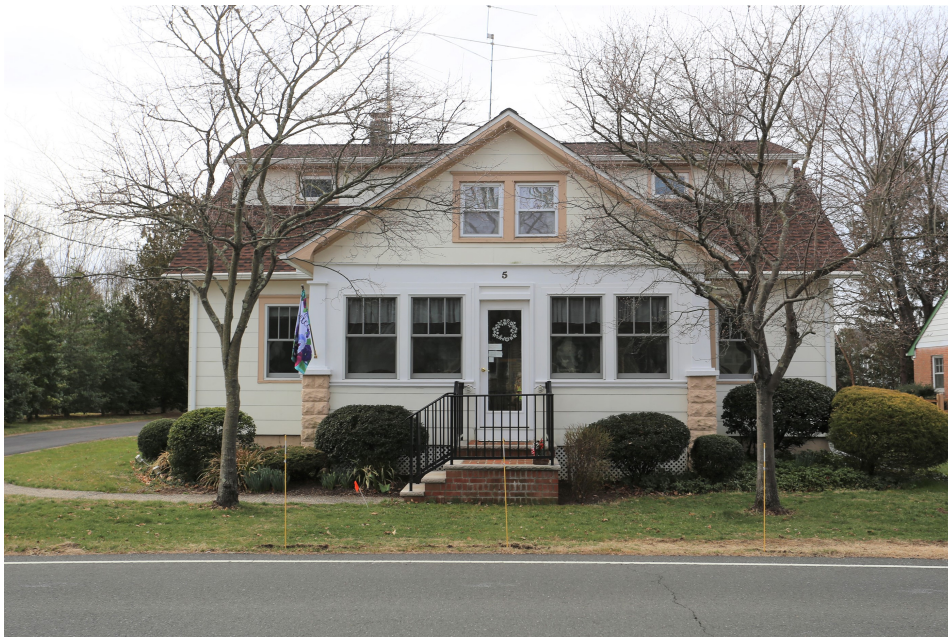
Property Photo:

5 Cranbury Neck Road is a one-and-one-half-story-tall, three-bay-wide, two-bay-deep, frame bungalow built circa 1929 in the Craftsman style. It consists of a side-gabled main block with an intersecting gable-roof enclosed porch on the primary (north) elevation, and a one-story, shed-roof wing on the rear (south) elevation. A large, gable-roof dormer interrupts both roof slopes of the main block (added circa 1973). An interior parged chimney pierces the roof of the dormer. The roof is sheathed in asphalt shingles and is accented by overhanging eaves. The exterior is clad in machined shingles. Windows are primarily three-over-one, vinyl-sash replacement units, with vinyl hopper windows in the dormer. Windows on the main block are set into wood surrounds with slightly molded lintels (likely original). The primary elevation is dominated by the enclosed porch, which contains paired, three-over-one, vinyl-sash windows and is supported by square, wood columns set on rusticated cast-stone bases (likely original). The central, primary entrance to the porch contains a glazed vinyl door, accessed by a brick stoop with metal railings. On the upper floor of the enclosed porch, there are paired, three-over-one, vinyl-sash windows set into wood surrounds similar to those seen on the main block. The east and west elevations of the main block have regular fenestration with vinyl-sash windows in the gable ends. The rear (south) elevation is not visible from the public right of way. The dwelling stands atop a parged foundation.

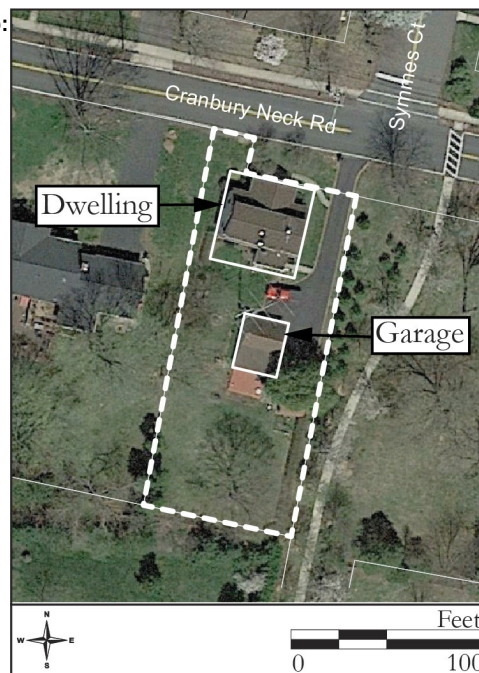
Site Map:

5 Cranbury Neck Road is sited on a rectangular parcel (Block 21, Lot 41.02) located on the south side of Cranbury Neck Road in Cranbury Township, Middlesex County, New Jersey. The dwelling is oriented with its primary elevation facing north and is set back approximately 20 feet from the road. An asphalt driveway extends along the east border of the property. Gravel paths lead from the driveway to the main entry and a rear entry. Mature trees and shrubs are planted within close proximity to the dwelling. The subject property is located in a residential neighborhood surrounded by properties dating from the mid-nineteenth to the early twentieth centuries.
