PROPERTY REPORT

Property Name: 12 Cranbury Neck Road

Survey Name: Cranbury Historic Sites Survey Phase III

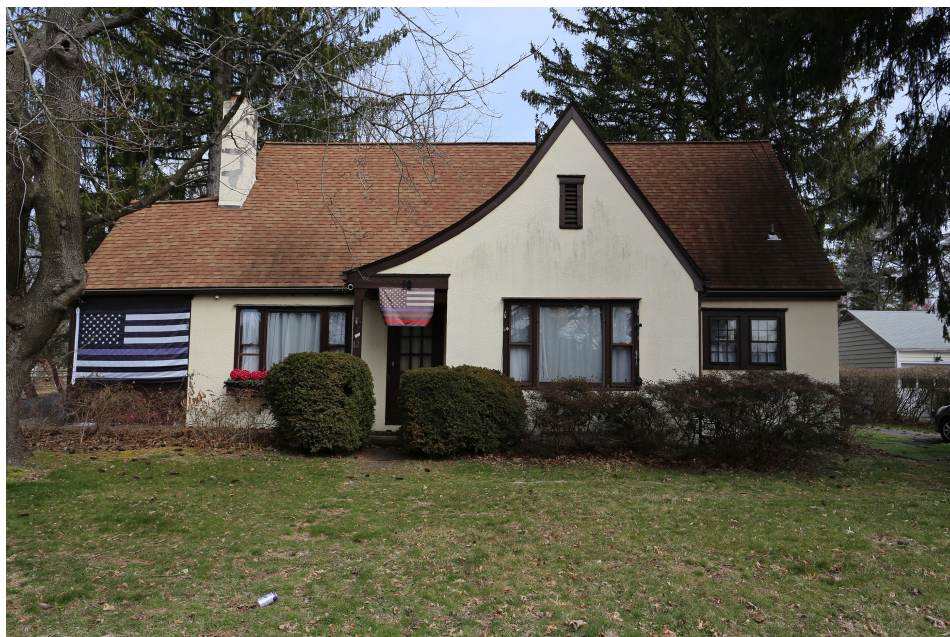
Property Photo:

12 Cranbury Neck Road is a one-and-one-half-story-tall, four-bay-wide, three-bay-deep, frame dwelling built circa 1933 in the Tudor Revival style. The dwelling consists of a side-gabled main block and an off-center, front-gabled wing with a flared eave that forms a covered porch. Extending from the west elevation is a one-story-tall side-gabled porch. An interior parged chimney rises above the roof junction of the main block and porch. The roof is sheathed in asphalt shingles. The exterior of the dwelling is covered in stucco (historic, likely original). Windows are primarily paired, six-over-six, wood-sash units, set within wood surrounds (historic, likely original) with aluminum storm windows. A tripartite vinyl window is featured in the west bay of the primary elevation of the main block and another is located on the front-gabled wing. The front-gabled wing also contains a wood louvered vent in the gable end. Situated in the second westernmost bay of the main block, beneath the porch formed by the flared eave of the front-gabled wing, the primary entrance features a wood French door (possibly historic) and is accessed by a concrete stoop. The east elevation of the main block contains a central, secondary entrance with a wood paneled door and a metal storm door, sheltered by a gabled portico with wood posts. The rear (north) elevation is not visible from the public right of way. The dwelling stands atop a parged foundation.

Character-defining elements of the dwelling include its massing, wood-sash windows, and front-gabled wing with a flared eave.
