# PROPERTY REPORT

Property Name:Elizabeth Debow HouseOwnership:PrivateAddress:17 N Main STApartment #:ZIP:08512

Survey Name: Cranbury CLG Survey 2017

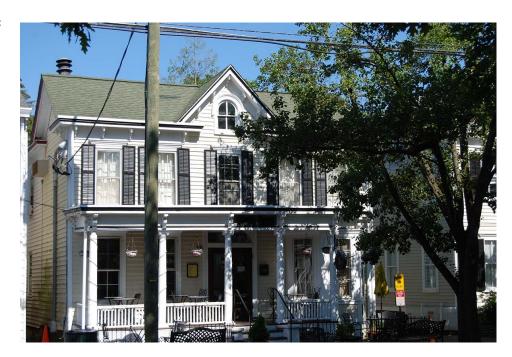
**Property Photo:**

The Elizabeth Debow House at 17 North Main Street is a two-and-a-half-story, five-bay, one-pile Gothic Revival style commercial building constructed circa 1850. The building currently houses a restaurant; it has a two-story rear addition on the rear and a one-story addition further west.

The building has a cross-gabled roof created by a centered cross-gable, which features an arched headed two-over-two wood sash window (possibly original). The roof is clad with asphalt shingles. A stove pipe is located near the south end of the ridge in the location of an original chimney. The molded cornice acts as an interior gutter system; it is supported by a row of thin brackets attached to a wood frieze. The wall surface is clad with wood clapboard siding. Fenestration is symmetrical. Windows are primarily six-over-six wood sash units (possibly original) with louvered shutters on the second floor. The front porch extends along the entire elevation; it has a flat roof, molded cornice, thick brackets, and five lonic columns (connected by a low railing with square balusters) supporting the porch eaves. An octagonal bay on the porch is aligned with the north end wall; it has a four-over-four window on each panel (possibly original). The central entrance consists of paired, one-light wood panel doors topped by a transom in a molded surround.

The north end wall faces onto a narrow passageway with the neighboring building. The extended eaves supported by the shaped brackets is visible above, along with the cornice returns. The wall surface is clad with vinyl siding. The elevation has a single rank of replacement

one-over-one windows near the northeast corner, located below the cornice return. The south elevation is a solid vinyl-clad wall below the molded cornice with shaped brackets and cornice returns.

The two-story rear addition extends along the entire rear (west) elevation of the main block. It has a gabled roof with extended eaves on the north and south side walls. The frame walls are clad with vinyl siding. Fenestration is asymmetrically spaced; windows are replacement one-over-one double hung sash units, with two ranks on the south elevation and one on the north. On the rear of this twostory addition is a one-story addition that is not visible from the public right-of-way.

Character-defining elements of the building include a bracketed cornice, a one-story full-façade porch with a bracketed cornice and Ionic columns, and a central cross-gable.
