PROPERTY REPORT

Property Name: 83 North Main Street

Survey Name: Cranbury CLG Survey 2017

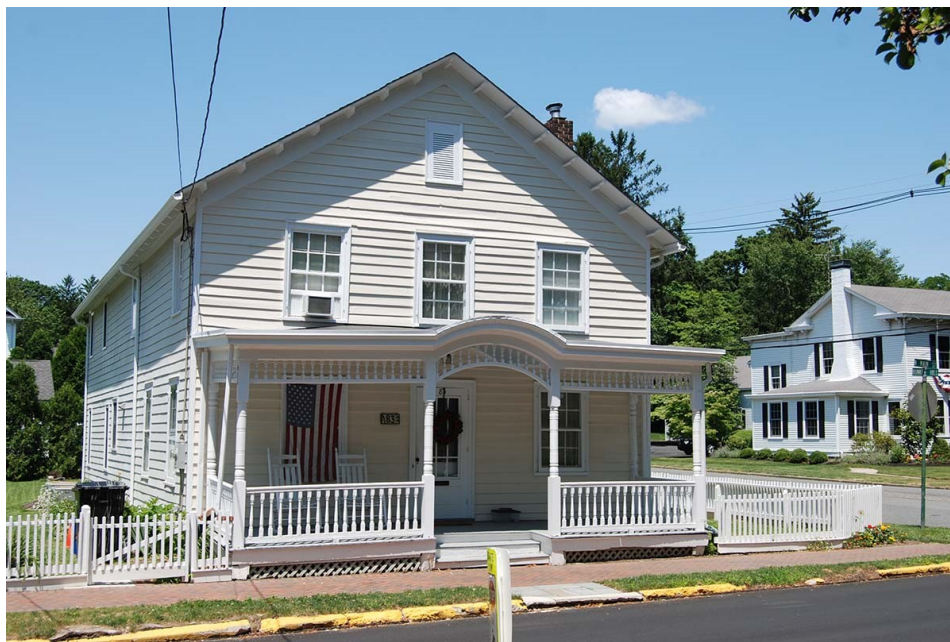
Property Photo:

83 North Main Street is a two-story tall, three-bay wide, three-bay deep, frame private residence constructed circa 1860 in a vernacular style with a Queen Anne style front porch. The dwelling consists of a rectangular, front-gabled main block, a two-story, three-bay rear addition, and a one-story, three-bay shed roof addition (both constructed circa 2000) to the rear. The roof is sheathed with asphalt shingles with overhanging eaves and exposed rafters. A capped, interior brick chimney pierces the roof on the northeast bent of the main block. The exterior of the dwelling is clad in wood clapboard siding on the front elevation and vinyl siding on the side elevations. A louvered window sits in the front gable end. Windows on the front elevation are six-over-six, double-hung, replacement wood-sash windows on the first and second floors. The central historic entrance is a two-panel wood door with a one-panel, wood screen door. The first floor is sheltered by a one-story, full-length porch with a hipped roof that is arched in the center. The porch has a frieze of spindles below the eaves and four turned posts connected by a low railing with thin turned balusters. Regular, symmetrical fenestration on the northeast elevation consists of six-over-six replacement wood-sash windows on the first and second floors. A recessed secondary entrance, a four-panel wood door with an aluminum storm door, is located in the east bay. The southwest elevation has six-over-six, double-hung, replacement wood-sash windows, arranged asymmetrically, on the first and second floors. Character-defining elements of the dwelling include the louvered gable end window, exposed rafters, and porch with spindlework details. A one-story, front-gabled garage (constructed circa 1960) is located west of the dwelling.

The 1989 Heritage Studies survey identified 83 North Main Street as a contributing property to the Cranbury Historic District. RGA concurs with the previous evaluation and recommends 83 North Main Street as a contributing property due to its date of construction and design.
