PROPERTY REPORT

Property Name: 77 North Main Street

Survey Name: Cranbury CLG Survey 2017

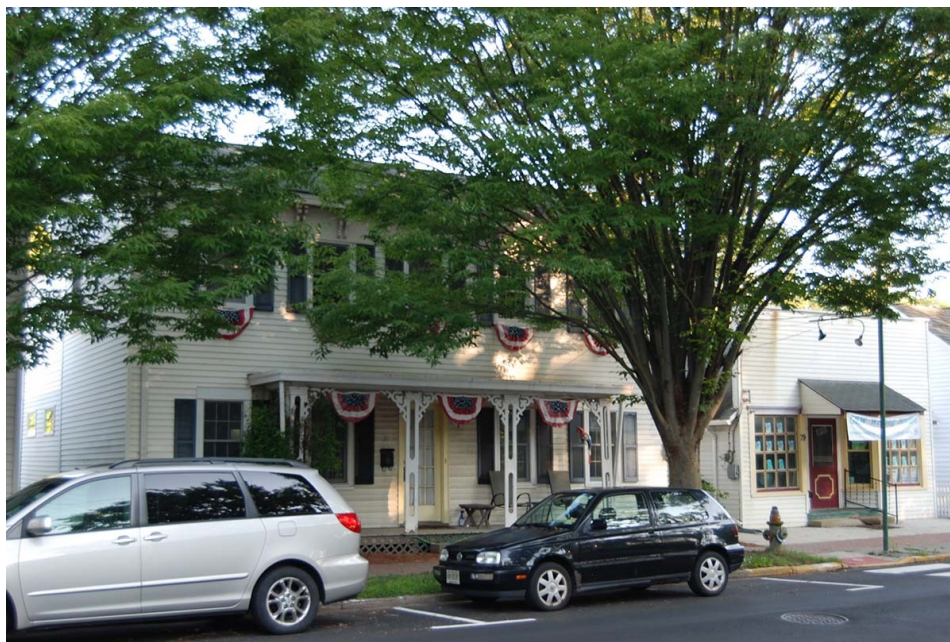
Property Photo:

77 North Main Street is a two-story, five-bay, two-pile, frame private residence constructed circa 1860. The building has a two-story rear ell aligned with its southern gable end wall and a one-story section aligned with its north end wall. The side-gabled roof is sheathed with asphalt shingles and features a molded cornice supported by a course of paired brackets. An exterior brick chimney pierces the roof on the north end. The exterior of the dwelling is clad in wood clapboard siding. Windows (all replacement units) vary from six over-six to six-over-one vinyl-sash flanked by louvered shutters. The second floor has five windows, and the first floor has two on each side of the centered entrance, a French door with multiple inset lights. The front porch covers the center three bays; it has a flat roof supported by thin posts connected with jigsaw spandrels. The house has a stone foundation.

The north elevation repeats the cladding of the main elevation (asphalt shingles on the roof and wood clapboard walls). The brick chimney is a major feature of the elevation. The cornice returns help frame rectangular louvered attic windows. The only wall opening on this end wall is a shuttered first floor window east of the chimney. The south end wall is similar in appearance, with an asphalt-shingled roof, wood clapboard walls, cornice returns, and attic louvers. Character-defining elements of the building include a bracketed cornice and wood frieze.
