PROPERTY REPORT

Property Name: 75 North Main Street
Address: 75 N Main ST
Ownership: Private
Apartment #:
ZIP: 08512

Survey Name: Cranbury CLG Survey 2017

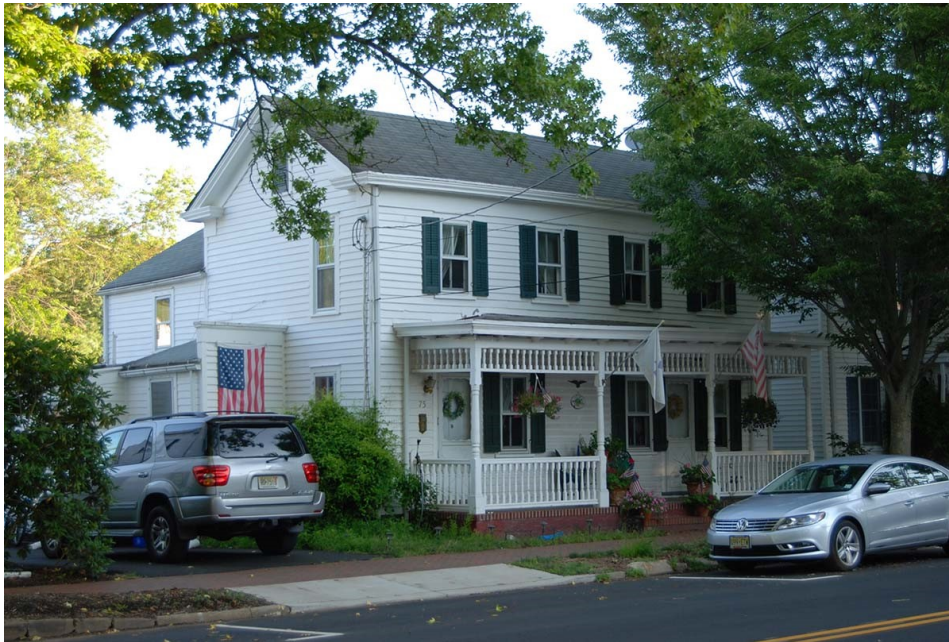
Property Photo:

75 North Main Street is a two-story, four-bay, two-pile, frame private residence constructed circa 1860. The house appears to be a two-part main block which has a two-story rear addition and small one-story rear, frame additions.

The main block faces east onto North Main Street. Its side-gabled roof is sheathed with asphalt shingles and features a molded cornice with an expressed wood frieze. The exterior of the dwelling is clad in wood clapboard siding. Fenestration consists of two-over-two, double-hung, wood-sash windows (dating to the late nineteenth century) within molded wood surrounds, flanked by louvered shutters. The second floor has four windows facing over the front porch, and the first floor has three windows and two doors. The front porch is a one-story, hipped roof element featuring a spindlework frieze, four turned columns, and a railing with turned balusters. Two paneled wood doors with aluminum screen doors open in the first and fourth bays of the first floor.

The south elevation has a molded cornice with cornice returns, wood clapboard walls, a four-over-two attic unit, and a single rank of two-over-two windows near the southeast corner. The north elevation is a solid wall clad with wood clapboards except for a four-over-two attic window. Character-defining elements of the dwelling include a one-story front porch with turned posts, a spindlework frieze, and turned balusters.
