New Jersey Department of Environmental Protection Historic Preservation Office

PROPERTY REPORT

Property Name:67 North Main StreetOwnership:PrivateAddress:67 N Main STApartment #:ZIP:08512

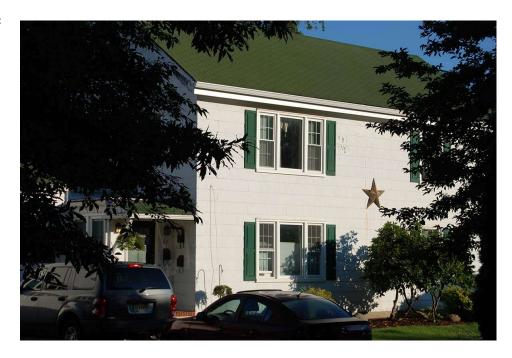
Property Photo:

67 North Main Street is a two-story, three-bay, two-pile, frame vernacular residence constructed circa 1940. The dwelling consists of a rectangular main block with an attached three-bay garage abutting the southwest elevation. The side gabled roof is sheathed with asphalt shingles. An interior brick chimney pierces the roof on the ridge of the garage. The exterior of the dwelling is clad in composite shingles. Fenestration is mostly symmetrical. Windows consist of three-part units with a center plate glass pane flanked by six-over-six double hung sash units that may be original. Each window unit is flanked by undersized paneled shutters. Entrance is gained to the dwelling through a one-story vestibule, set between the garage and the main block, with a four-panel, six-light door. Its foundation is concrete. The house is set back from the road, and other elevations are not visible from the public right-of-way.

The garage is a one-story, three-bay wing off the south end of the house. Its gabled roof is clad with asphalt shingles and features a centered shed-roofed dormer. The chimney is located north of the dormer. The garage's stuccoed walls have three wood roll-top doors with six inset lights each. Its foundation is concrete.
