## PROPERTY REPORT

**Property Name:** 55 North Main Street  
**Address:** 55 N Main ST

**Survey Name:** Cranbury CLG Survey 2017

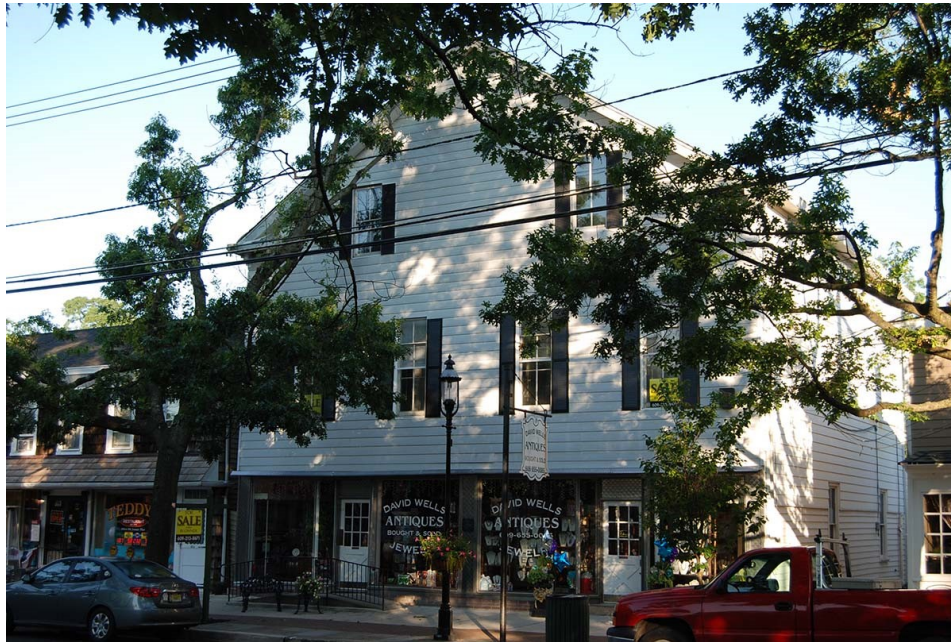
### Property Photo:

55 North Main Street is a three-story tall, five-bay wide, four-bay deep mixed residential and commercial building constructed circa 1869 in a vernacular Greek Revival style. The first floor functions as a storefront while the upper floors are subdivided into residential apartments. The building consists of a rectangular main block with two one-story frame additions to the northwest. The front-gabled roof is sheathed with asphalt shingles. The front gable is accentuated by a return cornice supported with wood brackets on each side. The exterior of the building is clad in aluminum siding with pressed aluminum panels on the first floor. Windows on the upper floors are two-over-two, double-hung, potentially original wood-sash windows with louvered shutters. The first floor storefront is pierced by large replacement, canted picture windows. The two entrances are replacement doors with nine inset lights above a crossbuck. The north entrance is accessed by a concrete stoop, while the south entrance is accessed by a concrete ramp with a metal railing. The northeast elevation is clad in wood clapboard siding on the first floor and aluminum siding on the upper floors. Two-over-two, double-hung, potentially original wood-sash windows perforate the elevation on the first and second floors. The third floor is distinguished by a row of paired one-over-one, double-hung, potentially original wood-sash arch windows. The rear elevation, clad in aluminum siding, features a return cornice in the gable end, two-over-two, double-hung, potentially original wood-sash windows on the second floor, and one-over-one, vinyl-sash replacement windows on the third floor. The first floor of the rear elevation is obscured by the two one-story additions, one with a shed roof and one with a front gable roof. The shed roof addition is clad in wood clapboard siding and features a fixed wood window with six inset lights, a single replacement screen door, and a brick exterior chimney on the rear. The front gable addition, also clad in wood clapboard siding, features

two two-over-two, double-hung, wood-sash windows and a fixed wood window beneath the gable peak. The southwest elevation of the subject building is not visible from the public right of way.
