PROPERTY REPORT

Property Name: Old Cranbury School
Address: 23 N Main ST

Survey Name: Cranbury Historic Sites Survey Phase III

PROPERTY REPORT: PHOTO CONTINUATION SHEET

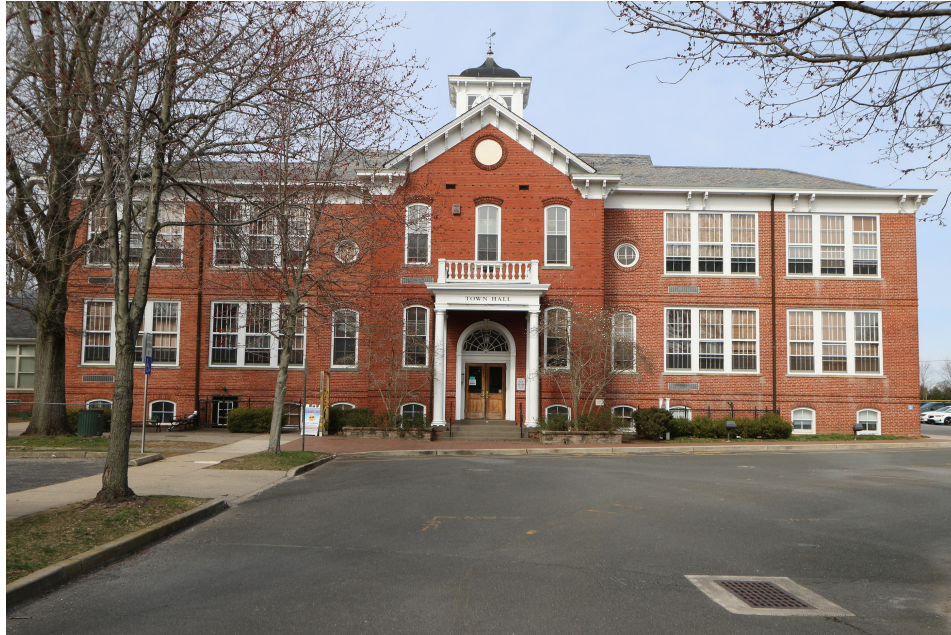
Property Photo:

Old Cranbury School at 23 North Main Street has undergone little to no alterations since Richard Grubb & Associates, Inc. surveyed it in 2017.

No changes from the 2017 survey.

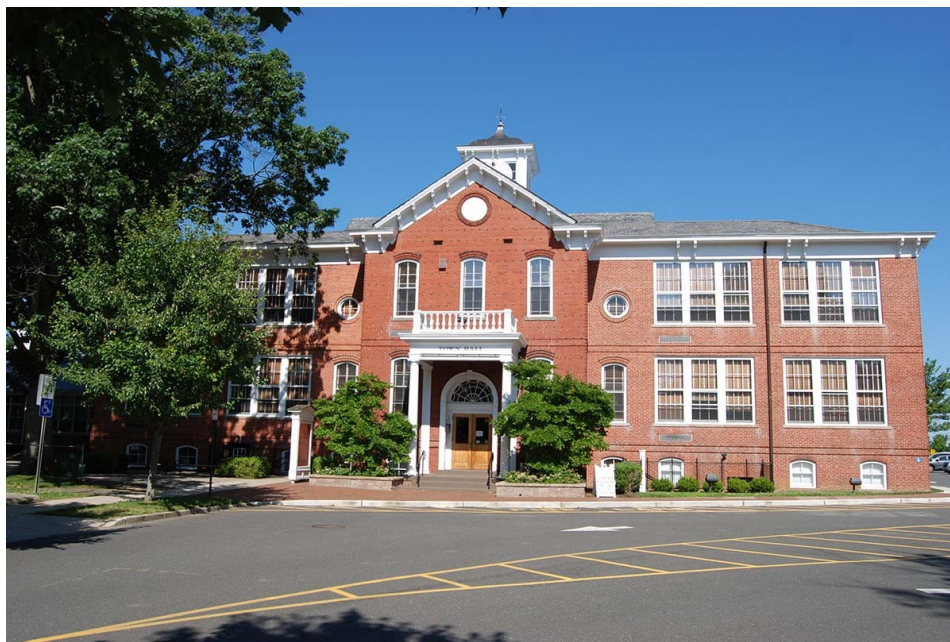
Property Photo:

Old Cranbury School at 23 North Main Street is a two-story, nine-bay, three-pile brick school building constructed in 1896. The main block of the building has multiple rear additions where the public library and the current school administration and classrooms are located. It is the largest building in the Cranbury Historic District. Only the main block of the building is described here; it currently serves as offices for Cranbury Township.

The main block is comprised of the core, which has the shape of a Greek cross, plus two-story wings that were added in the early twentieth century. The cross-gabled roof is clad with asphalt shingles and features a course of decorative brackets attached onto a frieze and returns on the front gable. The centered cupola features a metal weathervane over a bell-shaped roof, paired ogee brackets, and a large clock over multi-light windows. The walls are brick, with brick belt courses running horizontally between the basement and first floor and the first and second floors. Decorative elements of the brick walls include a sealed ocular window on the attic level, sporadic use of glazed headers, and rowlock arches over the windows. The projecting center bay features three replacement windows with segmental arched heads below rowlock jackarches on the second floor. A portico attached onto the projecting bay consists of a second floor balcony with turned balusters and an entablature supported by Doric columns that announce the entrance. Paired doors with plate glass windows provide access to the interior; they open below a semi-circular transom with spiderweb tracery and a keystone. Replacement four-over-four windows below rowlock arches flank the entrance and are aligned over arched headed basement windows.
