PROPERTY REPORT

Property Name: 25 North Main Street **Ownership:** Private
Address: 25 N Main ST **Apartment #:** **ZIP:** 08512

Survey Name: Cranbury CLG Survey 2017

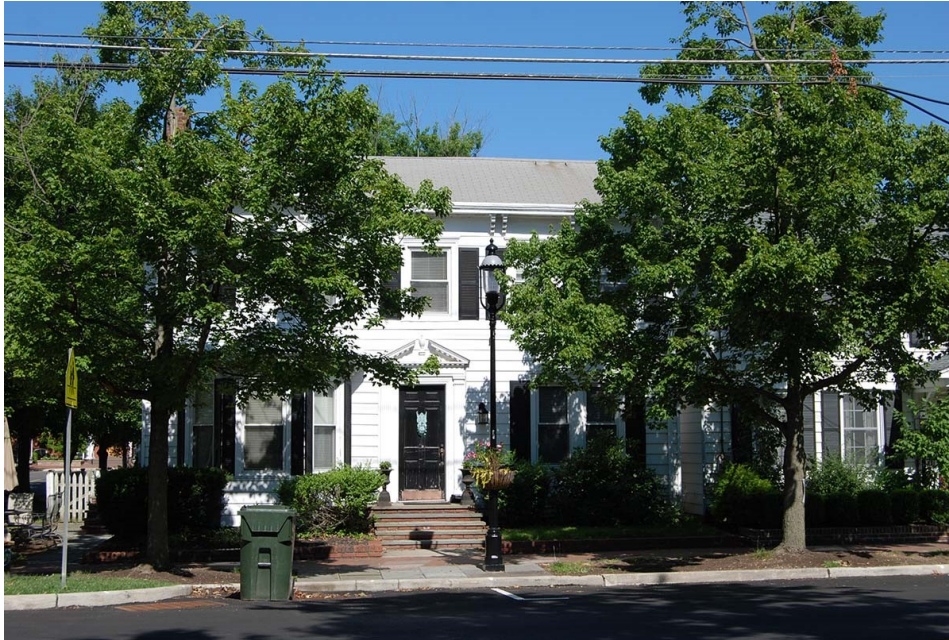
Property Photo:

25 North Main Street is a two-story, three-bay, one-pile Greek Revival style residence constructed circa 1860. The main block faces east onto Main Street and has a full-width two-story rear addition.

The main block has a side-gabled roof is sheathed with asphalt shingles. The molded cornice doubles as an interior gutter system and is supported by thick molded brackets. An interior brick chimney pierces the ridge near the south end wall. The exterior of the dwelling is clad in aluminum siding. Fenestration is mostly symmetrical. Windows are one-over-one, double-hung, wood sash (replacement) with molded lintels and louvered shutters. A key feature of the main elevation is a two-story octagonal bay aligned with the south end wall. The bay features a flat roof with a molded cornice that is incorporated into the main cornice of the house (complete with the heavy brackets). The walls of the bay are clad with aluminum, with a slight second floor flare over the first floor (heavy brackets are located below this flare). Windows on the bay are all replacement one-over-one units with undersized louvered shutters, with a window on each panel and each floor. North of the bay, the wall has two second bays. The second floor has single window units, but the first floor has a paired window north of the entrance, a six-panel wood door, flanked by fluted columns and topped by a broken pediment with an urn between and dentil trim. In front of the door is a four-step brick porch with a concrete landing. The house has a stone foundation.
