## PROPERTY REPORT

**Property Name:** 10 South Main Street

**Survey Name:** Cranbury Local Historic District Survey 2018

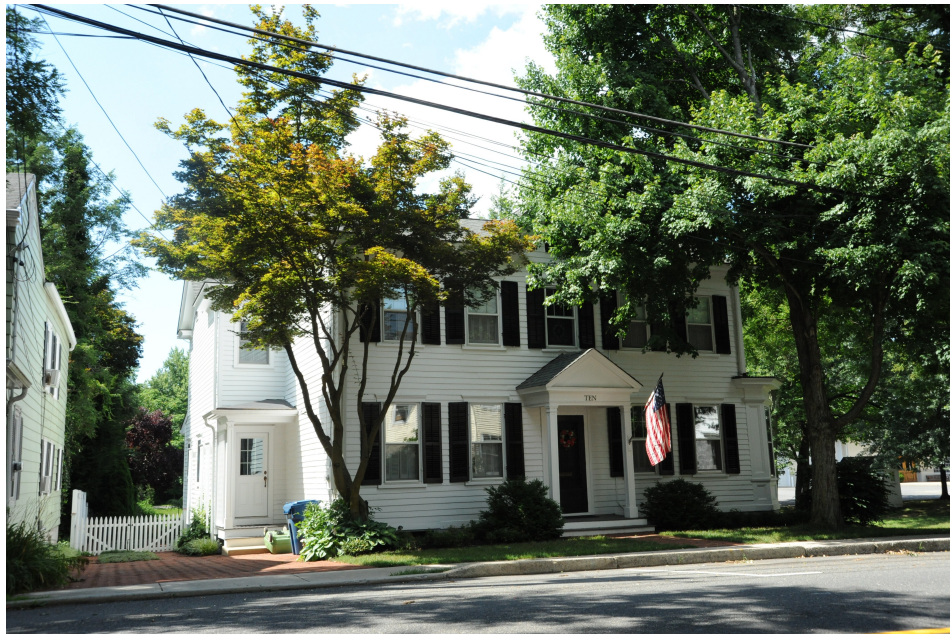
**Property Photo:**

The 2-story, gable-roofed, rectangular-plan main block of this replacement clapboard-clad, frame dwelling on a parged foundation is 5 bays wide and 2 bays deep and is fronted on the southeast by a 1-story, gable-roofed, 1-bay wide entry porch and backed on the northwest by a 2-story, cross gable-roofed, 3-bay deep, altered rear volume that wraps around the southwest, side elevation and is clad in cement board and includes replacement window sash. A wall gable is located in the central bay of the southeast elevation and a 1-story, composite-roofed, 3-sided window bay is in the southeast bay of the northeast elevation. The roofs are predominantly clad in asphalt single and the windows have 6/1 historic wood sash with historic louvered wood shutters. Interior, brick, ridge chimneys are located near the ends of the main volume. The replaced front entry porch, located in the central bay of the southeast, main elevation, includes historic, square-section posts with recessed panels and a pedimented gable. The primary entrance, located in the central bay and accessed by the porch, includes a historic paneled door and historic storm door. The remaining bays of both floors are regularly fenestrated. A shuttered, segmental arch window lights the wall gable. The northeast, side elevation is lighted by 3 windows with stained glass upper sash in the window bay and a single window in the east bay of the second floor of the main block. The rear volume is lighted by a single window on each floor. The northwest, side elevation is not visible from the public right-of-way. The southwest, side elevation is lighted by 2 windows

on the first floor. A secondary entrance with a hip-roofed door hood, located in the southeast elevation of the extended bay of the rear volume, includes a historic, square-section post with recessed panels. A single window lights the second floor. A 1-story, gable-roofed, frame garage with a 1-story, shed-roofed side volume is located to the northwest of the residence.

The residence at 10 S. Main Street is a contributing property in the Cranbury Historic District because it retains integrity and historic, character-defining features such as its historic door and storm door, historic stained glass, and historic shutters. However, the visibility of the large-scale rear volume from the public right-of-way makes this status marginal.
