PROPERTY REPORT

Property Name: Joseph Carson House
Address: 18 S MAIN ST

Survey Name: Cranbury Local Historic District Survey 2018

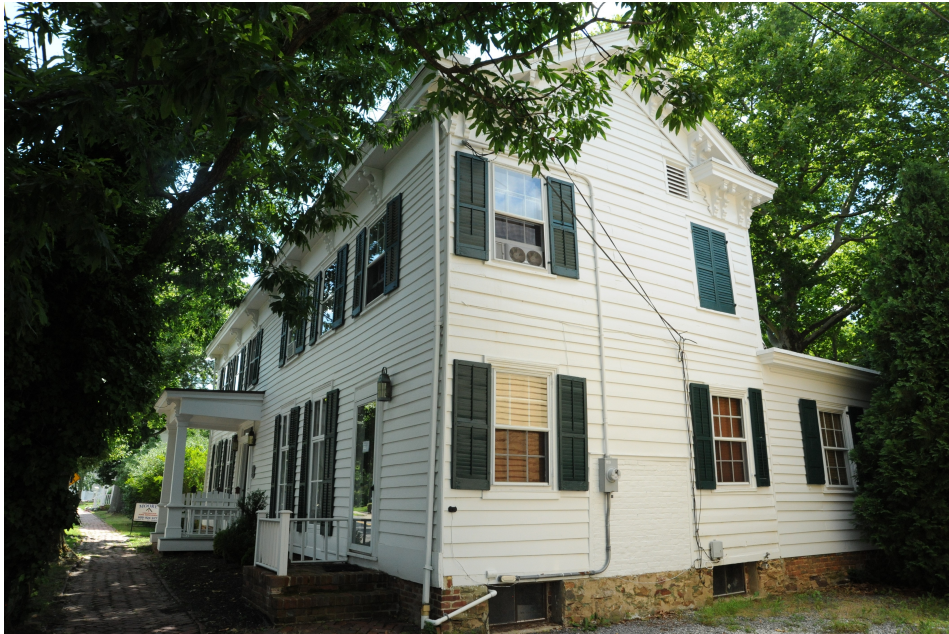
Property Photo:

The 2-story, gable-roofed, rectangular-plan main block of this clapboard-clad, frame residence on a brick and stone foundation is 6 bays wide and 2 bays deep and is fronted on the southeast elevation by a 1-story, shed-roofed, 1-bay wide porch and backed on the northwest elevation by a 2-story, gable-roofed, partial width volume. The roofs are predominantly clad in asphalt shingle with historic wood brackets and eave returns at the gable ends. The windows predominantly have 6/6 historic wood sash, with double-hung wood French doors on the first floor of the southeast elevation. A substantial interior brick chimney projects from the southwest bay of the gable ridge. The front porch, located off-center in southwest, central bay of the southeast elevation, includes square-plan posts, historic wood brackets, and a historic rail with square-plan balusters. The primary entrance, accessed by the porch, includes a historic door with historic single-light sidelights over a recessed panel and a historic single-light transom. A secondary entrance, located in the northeast bay, is accessed by a brick stair with a simple rail and includes a historic 4-light door. The remaining bays of the first floor are each lighted by a shuttered French door with 2-light transoms. The second floor of the southeast elevation, and both floors of the northeast and southwest side elevations of the main block are regularly fenestrated. Both side elevations include an exposed painted brick fireback on the first floor. The northeast elevation includes a central stone foundation joined with the brick foundation of the rear volume and the southeast elevation. The 1-story

rear volume is lighted by a single window on its northeast elevation. The remaining rear volumes and the northeast, rear elevations are not visible from the public right-of-way.

18 S. Main is a contributing property in the Cranbury Historic District because it retains integrity and historic, character-defining features such as its historic windows, historic doors, historic wood brackets, historic shutters, historic clapboard, and historic porch posts and a historic porch rail.
