PROPERTY REPORT

Property Name: 42 South Main Street
Address: 42 S MAIN ST

PS&S recommends that 42 S. Main Street, which includes a residence and garage constructed circa 1910, is a contributing property in the Cranbury Historic District.

Survey Name: Cranbury Local Historic District Survey 2018

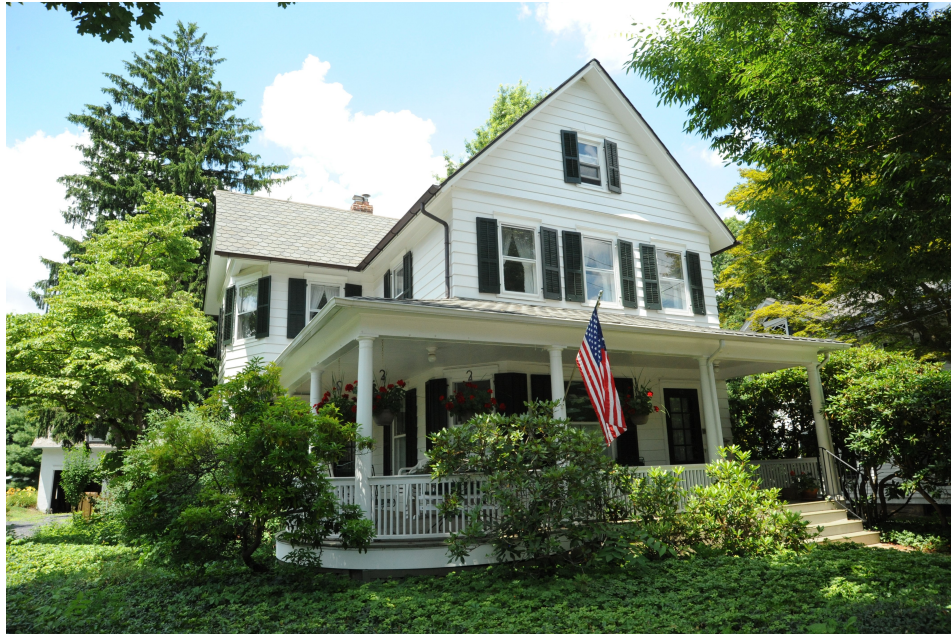
Property Photo:

The 2 1/2-story, gable-roofed, rectangular-plan main block of this painted aluminum siding-clad, L-plan frame dwelling on a covered foundation is 3 bays wide and 2 bays deep and is fronted on the southeast, main and southwest, side elevations by a 1-story, hip-roofed, wrap-around porch that meets the gabled side volume, which includes a 3-story window bay on its southwest elevation. The main block is backed on the northwest by a partial-width, hip-roofed, 1-story rear el that is flanked on the southwest by a 2-story entry porch. The roofs are predominantly clad in shaped asphalt shingle and the windows predominantly have 1/1 historic wood sash. An interior brick chimney projects from the southwest slope of the rear of the main volume. The front porch, which has an extended, rounded bay at the southeast corner, is accessed by a straight wood stair in the northeast bay of the southeast elevation and a brick stair in the northwest bay of the southwest elevation, and includes historic Tuscan columns and a historic rail with square-plan balusters. The primary entrance, located in the northeast bay of the main elevation, includes a historic 8-light door. A large 1/1 window lights the central bay of the first floor. The southwest bay, which is chamfered, is lighted by a single window. The second floor is regularly fenestrated and the third floor is lighted by a single window. The northeast, side elevation is regularly fenestrated and includes an offset window in the central bay that suggests an interior stairwell. The southwest, side elevation is regularly fenestrated in both the main and rear volumes. An entrance to the rear volume

is located on its southeast elevation. A stair provides access to a door to the rear enclosed porch. The northwest, rear elevation is not visible from the public right-of-way.

A 1 ½-story, 2-bay, gabled, historic, stuccoed terra cotta tile garage is located west of the house at the rear of the lot. The roof is clad in asbestos shingles and the historic, sliding barn door with 9-light upper lights survives on the main, southeast elevation.

The residence at 42 S. Main Street contributes in the Cranbury Historic District because it retains integrity and such historic character-defining features as its historic wood windows, wood shutters, front door, porch columns, historic porch rail and balusters, and historic massing and fenestration patterns, and its historic garage, with its historic surface materials and garage doors.
