PROPERTY REPORT

Property Name: 46 South Main Street

Survey Name: Cranbury Local Historic District Survey 2018

Organization: Paulus, Sokolowski & Sartor

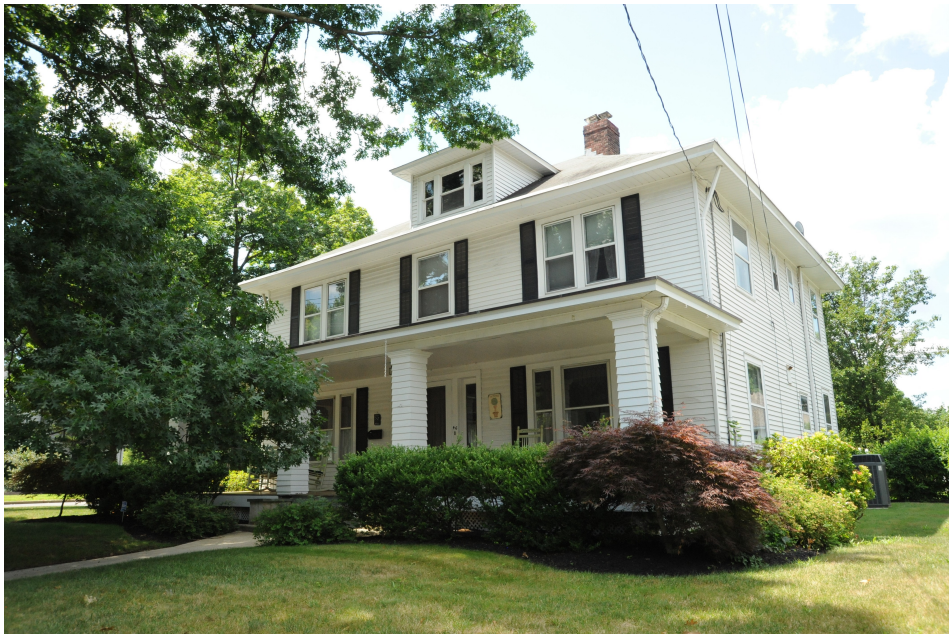
Property Photo:

The 2 1/2-story, hip-roofed, foursquare main block of this replacement siding-clad, frame residence on a parged foundation is 3 bays wide and 3 bays deep and is fronted on the southeast by a 1-story, hip-roofed, full-width porch and backed on the northwest by a 1-story, hip-roofed, partial-width rear el offset to the northeast that is flanked on its southwest side by a 1-story, shed-roofed volume. A 1-story, hip-roofed, enclosed porch projects from the central bay of the southwest, side elevation, with a hip-roofed, abutting oriel to the southeast and a 2-story, hip-roofed, 3-sided window bay abutting it to the northwest. Hip-roofed dormers project from the southeast and northwest roof slopes and an interior brick chimney projects from the northeast slope, near the peak. The roofs are predominantly clad in asphalt shingle and the windows predominantly retain 1/1 historic wood sash, with applied vinyl shutters on the main elevation. The front porch, accessed by a centered stair, includes wood clapboard-clad, square-plan posts. The centered main entrance includes historic, single-light side lights. The outer bays of the first floor are both lighted by triple windows with a larger sash flanked on each side by a smaller, 1/1 sash. The second floor is lighted by a single window in the central bay and double windows in the outer bays. The dormer is lighted by a triple window with smaller side sash on a smaller scale than those of the first floor. The northeast, side elevation is regularly fenestrated, though the window size is smaller in the central bay. The southwest, side elevation is regularly fenestrated, with a paired window in the first floor oriel.

The enclosed porch covers the southeast side of the window bay. The porch is lighted by paired, triple awning windows on each elevation except the southeast, which is lighted by a single set of windows and accessed by an adjacent secondary door. The northwest, rear elevation is not visible from the public right-of-way. The 1-story, hip-roofed, clapboard clad garage includes exposed rafter tails and windows with historic 16/1-light, wood sash.

46 S. Main Street is a contributing property in the Cranbury Historic District because it retains integrity and character-defining historic features such as its historic massing, historic window sash, and historic door surround. The garage retains its historic window sash, exposed rafter tails, and siding materials.
