PROPERTY REPORT

Property Name: 8 Cranbury Neck Road
Address: 8 Cranbury Neck RD

Survey Name: Cranbury Historic Sites Survey Phase III

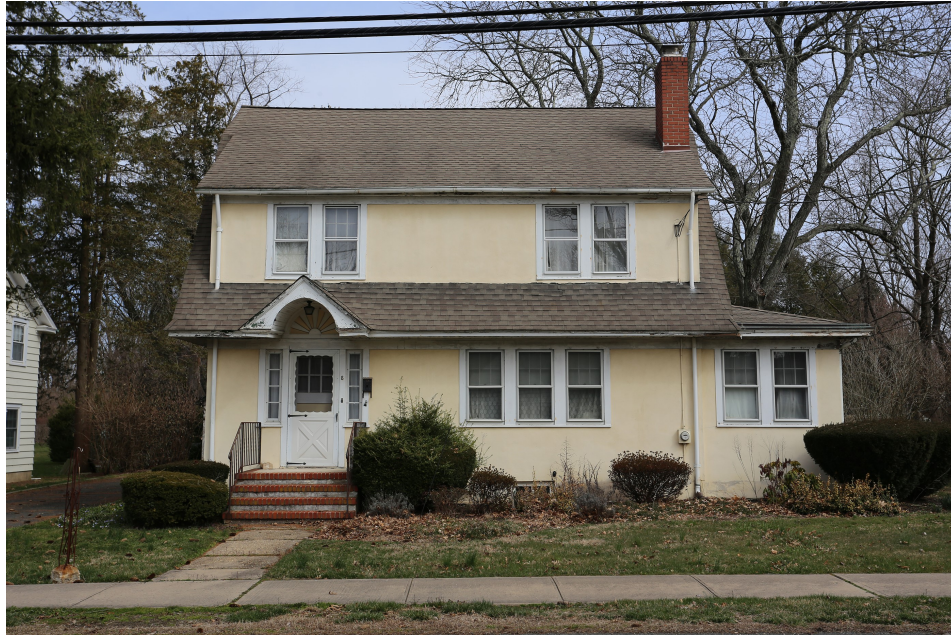
Property Photo:

8 Cranbury Neck Road is a two-and-one-half-story-tall, three-bay-wide, two-bay-deep, frame dwelling built circa 1928 in the Dutch Colonial Revival style. The dwelling consists of a gambrel-roof main block with a one-story, hipped-roof wing on the southeast elevation and a one-story, shed-roof wing on the rear (north) elevation. The roof is clad in asphalt shingles and is accented by a molded wood cornice. Full-length, shed-roof dormers extend across the primary (south) and rear slopes of the main block's roof. An exterior brick chimney is located on the southeast elevation of the main block. The exterior of the dwelling is covered in stucco (historic, likely original). Windows are all single and grouped, six-over-one, wood-sash units, set within wood surrounds with slightly molded lintels (historic, likely original) with aluminum storm windows. Located in the westernmost bay on the primary elevation, the primary entrance contains a six-light, wood Dutch door with a metal storm door and segmented vinyl sidelights. Above the door, there is a semicircular, wood transom with a sunburst motif (historic, likely original). The entrance is sheltered by a gabled hood with a molded wood cornice (historic, likely original) and is accessed by a concrete and brick stoop with metal railings. The east and west elevations of the main block have a symmetrical fenestration, with wood-sash windows in the gambrel ends and a pent roof sheltering the first floor. The west elevation features a central, secondary entrance containing a wood door with a metal storm door. The east wing has symmetrical fenestration on its primary and east elevations. The rear elevation of the dwelling is not visible from the public right-of-way. The dwelling stands atop a parged foundation, with two-light hopper windows at the basement level visible on the primary and west elevations.

Character-defining elements of the dwelling include its massing, gambrel roof, full-length shed-roof dormers, wood-sash windows, molded wood cornice, and gabled hood with sunburst motif.

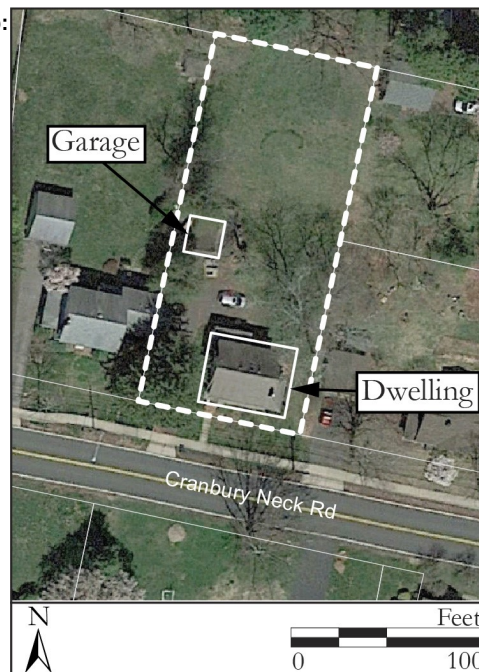
Site Map:

A one-story-tall, two-bay-wide, frame garage, constructed circa 1928, stands approximately 45 feet to the north of the dwelling. The exterior is clad in wood plank siding and the roof is sheathed in asphalt shingles. The primary (south) elevation features two double-leaf, paneled wood doors with twelve inset lights.
