PROPERTY REPORT

Property Name: 10 Cranbury Neck Road
Address: 10 Cranbury Neck RD

Survey Name: Cranbury Historic Sites Survey Phase III

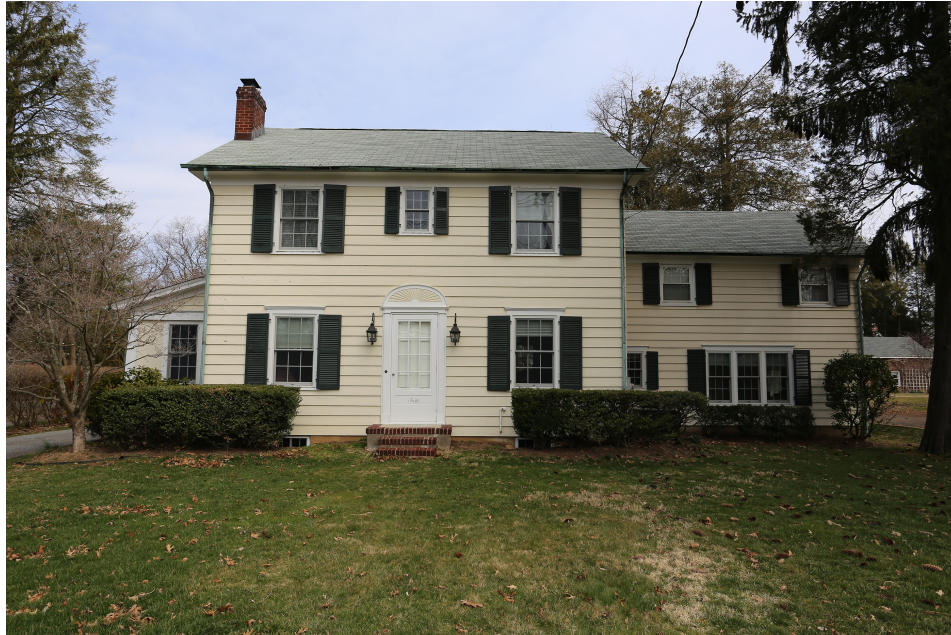
Property Photo:

10 Cranbury Neck Road is a two-and-one-half-story-tall, three-bay-wide, two-bay-deep, frame dwelling built circa 1932 in the Colonial Revival style. The dwelling consists of a side-gabled main block with a two-story-tall, side-gabled, east addition (added in 1939), a one-story-tall, shed-roof, west wing (formerly a porch, now enclosed), and a one-story-tall, hipped-roof, rear (north) wing. An off-center, exterior brick chimney pierces the west gable end of the main block. The roof is sheathed in asphalt shingles throughout and features a molded wood cornice with gable end returns on the main block and east addition. A wood frieze accents the roof line on the primary (south) elevation of the main block and the east addition. The exterior of the dwelling is clad in wood clapboard siding. Windows throughout are six-over-six, vinyl-sash replacement units set within wood surrounds with slightly molded lintels (original). Louvered vinyl shutters flank the windows on the primary elevation of the main block and east addition. The primary elevation of the main block has symmetrical fenestration. The central, primary entrance contains a wood paneled door with a glazed vinyl storm door (added circa 2008), set within a wood surround with unfluted pilasters and a semicircular sunburst motif (original). The entrance is accessed by a concrete and brick stoop. The east and west elevations of the main block have symmetrical fenestration, with semicircular vinyl replacement windows in the gable ends. The east addition contains single and grouped, vinyl-sash replacement windows on its primary and east elevations. The west addition features square wood columns supporting a plain wood frieze, with a vinyl-sash window on the primary elevation. On its west elevation, there is a secondary entrance containing a wood paneled door and a glazed vinyl screen door. The rear elevation is not visible from the public right-of-way. The dwelling stands atop a parged foundation.

A one-story-tall, two-bay-wide, frame garage stands approximately 20 feet north of the dwelling. Its side-gabled roof is sheathed in asphalt shingles and the exterior is clad in wood clapboard siding. The primary (south) elevation contains two metal roll-top doors.

Character-defining elements of the dwelling include its massing, fenestration pattern, wood window surrounds, molded wood cornice with gable-end returns, and wood door surround with sunburst motif.

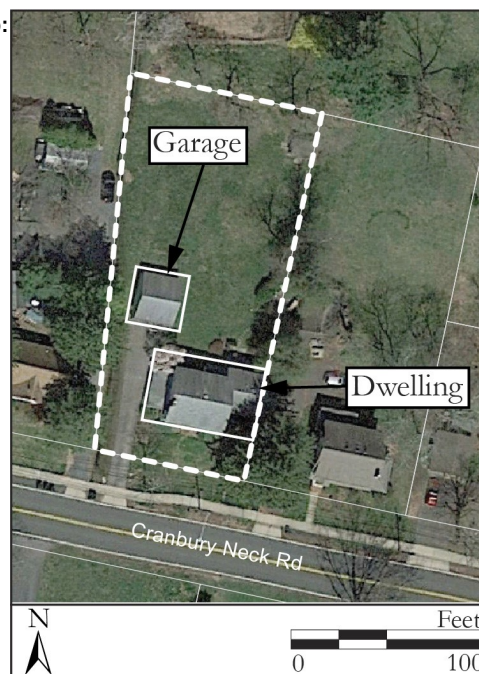
Site Map:

10 Cranbury Neck Road is sited on a rectangular parcel (Block 23, Lot 94) located on the north side of Cranbury Neck Road in Cranbury Township, Middlesex County, New Jersey. The dwelling is oriented with its primary elevation facing south and is set back approximately 45 feet from the road. An asphalt-paved driveway extends along the northwest border of the property and leads to the garage. A concrete sidewalk lines the south border of the property. Mature trees and shrubs are planted within close proximity to the dwelling. The subject property is located in a residential neighborhood surrounded by properties dating from the mid-nineteenth to the early twentieth centuries.
