PROPERTY REPORT

Property Name: 175 North Main Street
Address: 175 N Main ST

Survey Name: Cranbury Historic Sites Survey Phase III

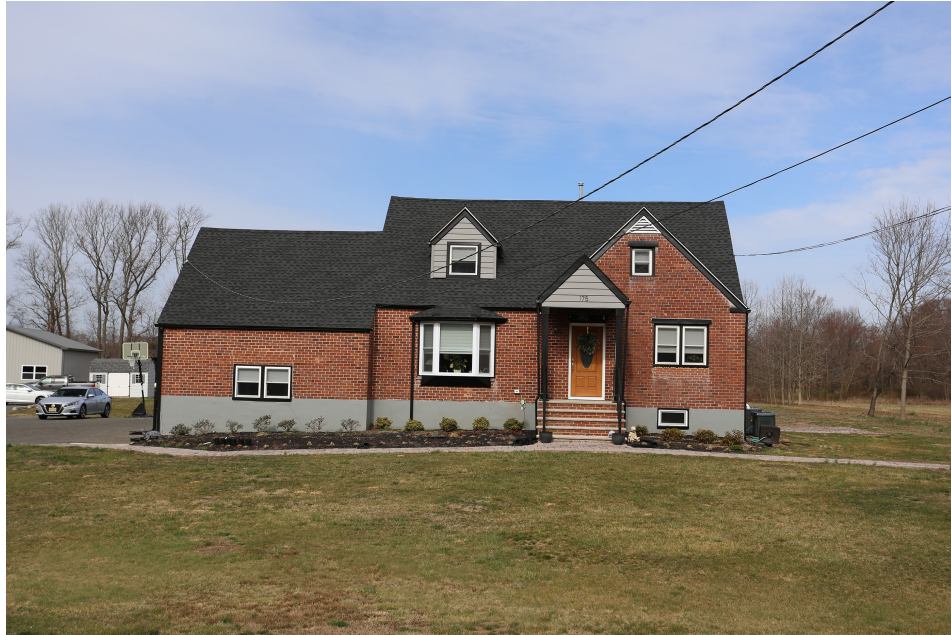
Property Photo:

175 North Main Street is a one-and-one-half-story-tall, three-bay-wide, two-bay-deep, brick dwelling built circa 1945 in the Minimal Traditional style. It consists of a side-gabled main block and a one-bay-wide, three-bay-deep, southwest wing. The primary (southeast) slope of the main block is interrupted by a two-bay-wide, front-gabled wall dormer in the northeast half and a front-gabled dormer centered in the southwest half. A full-length shed dormer extends along the rear (northwest) slope of the main block. The roof is sheathed in asphalt shingles and the dormers are clad in vinyl siding. The exterior of the dwelling is clad in brick laid in running bond. Vinyl louvered vents are located in each of the gable peaks on the main block. Windows vary between one-over-one, vinyl-sash replacement and vinyl casement units, set within vinyl surrounds. A hipped-roof, vinyl bay window is located in the southwestern bay of the primary elevation of the main block. Located in the center bay of the main block, the main entrance contains a wood panel door with an oval light. It is sheltered by a front-gabled portico supported by square wood posts and accessed by a brick stoop with metal railings. A raised parged foundation water table extends across the primary and northeast elevations. The southwest wing is clad in vinyl siding on the southwest elevation, featuring brick below the windows. A secondary entrance, containing a modern wood door, is located in the center bay and features a front-gabled portico supported by wood posts. The rear elevation is not visible from the public right-of-way. The dwelling stands on a parged foundation.
