New Jersey Department of Environmental Protection Historic Preservation Office

# PROPERTY REPORT

**Property Name:** Isaac Snedeker House Ownership: Private 165 N Main ST **ZIP:** 08512 Address: Apartment #:

Survey Name: Cranbury CLG Survey 2017

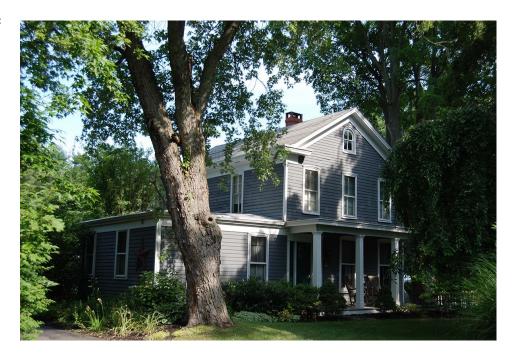
### **Property Photo:**

The Isaac Snedeker House at 165 North Main Street is a two-and-a-half-story tall, three-bay wide, two-bay deep, frame private residence constructed circa 1860 with vernacular Gothic Revival details. The dwelling, which sits on a brick foundation, consists of a rectangular, front-gabled main block and three one-story, frame additions: a two-bay, hipped roof addition to the southwest, a three-bay, hipped roof addition to the northwest, and an enclosed porch on the northeast elevation of the northwest addition. The roof is sheathed with fiberglassasphalt shingles. The dwelling features a molded wood cornice with a return cornice at the gable ends of the main block and a wood frieze. An interior brick chimney pierces the roof on the northeast bent of the main block. The exterior of the dwelling is clad in wood clapboard siding on all elevations. A two-over-two, double-hung, original wood-sash arched window sits in the front gable end. Windows on the front elevation of the main block and the southwest addition are two-over-two, double-hung, original wood-sash windows with molded wood surrounds and arched lintels. Windows on the first floor of the main block have wood walkout windows. The primary entrance, located in the south bay on the main block, is a replacement door with six inset lights above a large rectangular panel. Sidelights with two inset lights and molded rectangular panels flank the door, which is set within a molded wood surround. A one-story porch shelters the three bays on the main block. The porch has a flat roof, a molded wood cornice and frieze, and square columns. The northwest elevation features two-over-two, double-hung, original wood-sash windows with molded wood surrounds and arched lintels. The one-story enclosed porch, with segmented wood screen windows and a wood screen door, abuts the west corner of the elevation. The rear elevation is not visible from the public right-of-way. On the southwest elevation, a semi-hexagonal projecting bay sits in the west bay on the second floor
