## PROPERTY REPORT

**Property Name:** 139 North Main Street  
**Address:** 139 N Main ST

**Survey Name:** Cranbury Historic Sites Survey Phase III

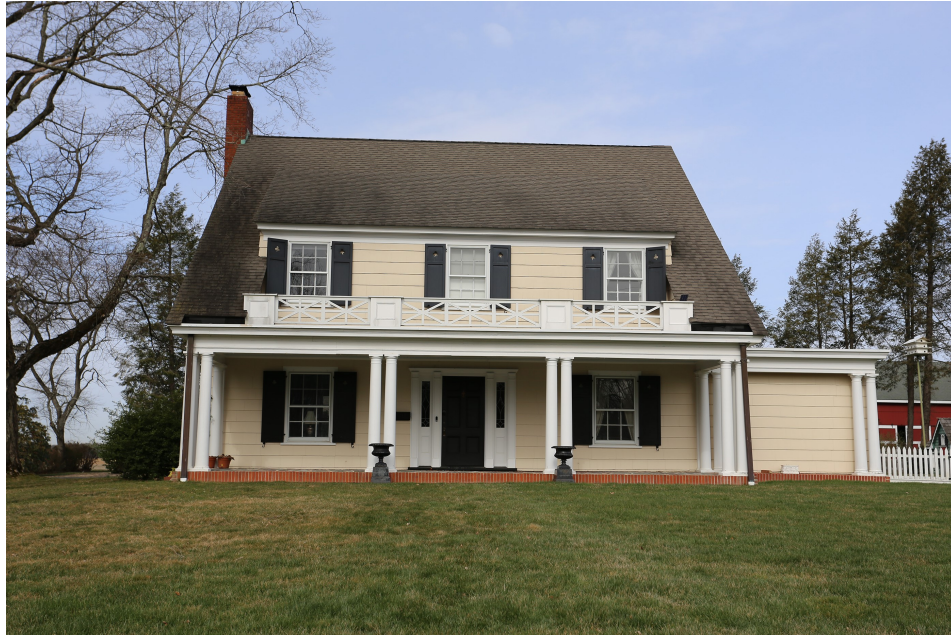
### Property Photo:

139 North Main Street is a two-and-one-half-story-tall, three-bay-wide, two-bay-deep, frame dwelling built in 1929 in the Colonial Revival style. The dwelling consists of a side-gabled main block with a one-story, flat-roof, wing (likely an original enclosed porch) on the northeast elevation and a small, one-story, flat-roof addition at the northwest corner (added circa 1975). A three-bay-wide, shed-roof dormer interrupts the main block's primary (southeast) roof slope and an exterior brick chimney extends above the southwest gable end. The roof is sheathed in asphalt shingles. The exterior of the dwelling is clad in machined shingles. Windows on the main block are six-over-six, wood-sash units set within wood surrounds (historic, likely original) with aluminum storm windows. Wood shutters with spade motifs and metal shutter dogs flank the windows on the primary elevation on both the first and second floors. The shutters on the first floor were installed sometime prior to 2013 and may be original to the dwelling, while the shutters on the second floor were installed around 2016. The primary elevation of the main block has a symmetrical fenestration and features a full-length porch with paired, wood Doric columns (historic, likely original). A wood balustrade with a criss-cross pattern lines the roof of the porch in front of the dormer. The central primary entrance contains a six-panel wood door set within a wood surround and flanked by square pilasters and wood sidelights (historic, likely original). The northeast and southwest elevations both have symmetrical fenestration, with a metal, louvered vent in the gable end of the northeast elevation. Similar to the porch on the main block, paired wood Doric columns accent the corners of the northeast wing. A large, replacement wood picture window is centered on the northeast elevation of the northeast wing. The one-story, northwest addition and the rear (northwest) elevation are not visible from the public right-of-way. The foundation is not visible.

Character-defining elements of the dwelling consist of its massing, three-bay-wide dormer, wood-sash windows, paired wood Doric columns, and wood balustrade with a criss-cross pattern.
