PROPERTY REPORT

Property Name: 135 North Main Street
Address: 135 N Main ST

Survey Name: Cranbury Historic Sites Survey Phase III

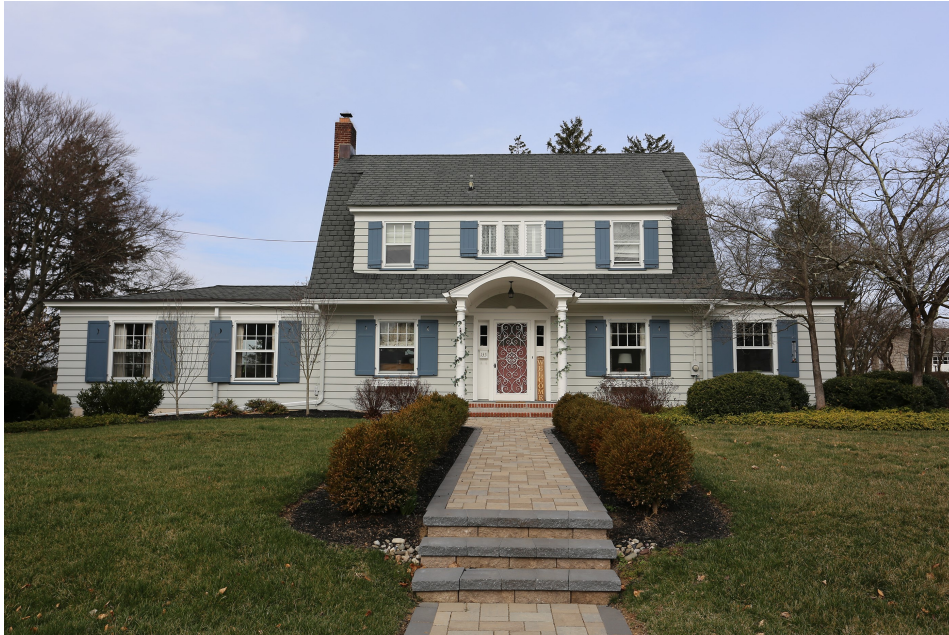
Property Photo:

135 North Main Street is a two-and-one-half-story-tall, three-bay-wide, two-bay-deep, frame dwelling built circa 1925 in the Dutch Colonial Revival style. The dwelling consists of a side-gambrel-roof main block, with one-story, hipped-roof wings extending from the northeast and southwest elevations. The northeast wing is likely an original porch which was later enclosed, and the southwest wing was constructed circa 1960. A circa-1995, two-story, hipped-roof addition, with a one-story extension to the southwest, projects from the rear (northwest) elevation. Interrupting the primary (southeast) roof slope of the main block is a three-bay-wide, shed-roof dormer. An exterior brick chimney extends above the main block's southwest roof peak. The roof is sheathed in asphalt shingles. The exterior of the dwelling is clad in composite siding. Windows are generally eight-over-one and six-over-one, vinyl-sash replacement units with aluminum storm windows. Wood shutters with moon motifs flank most of the windows on the primary, northeast, and northwest elevations of the main block and wings, with wood-plank shutters on the windows in the dormer (likely replacement). A tripartite louvered window is featured in the center bay of the dormer. The central, primary entrance contains a wood door with six lights (possibly original), set within a wood surround with segmented sidelights and a wood sunburst motif (possibly original) and sheltered by a gable-roof portico with wood Doric columns (possibly original). The entrance is accessed by a concrete and brick stoop. The northeast elevation of the main block features a semicircular, fixed vinyl window at the attic level. A vinyl, fixed-pane window is located on the northeast elevation of the northeast wing. Windows on the southwest wing consist of symmetrically placed, eight-over-eight, vinyl-sash replacement units on the primary elevation and a vinyl bay window centered on the southwest elevation. A one-story porch wraps around the north corner of the dwelling, supported by simple wood posts. The remainder of the rear elevation is not visible from the public right-of-way. The foundation is not visible.

Character-defining elements of the dwelling consist of its massing, three-bay-wide dormer, gambrel roof, and primary entrance with a wood sunburst motif.
