PROPERTY REPORT

Property Name: 131 North Main Street
Address: 131 N Main ST

Survey Name: Cranbury Historic Sites Survey Phase III

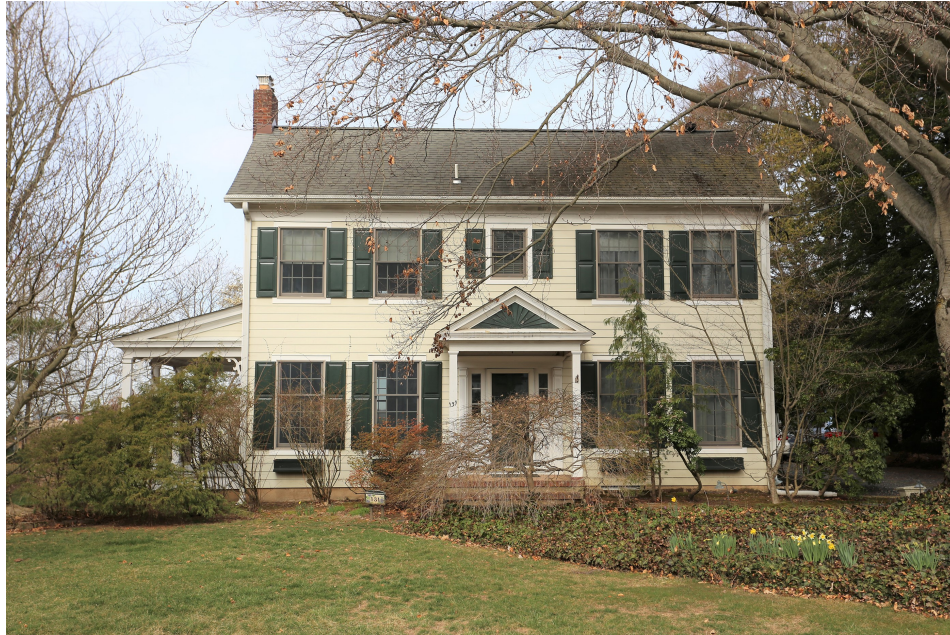
Property Photo:

131 North Main Street is a two-and-one-half-story-tall, five-bay-wide, two-bay-deep, frame dwelling constructed circa 1926 in the Colonial Revival style. The dwelling consists of an L-shaped footprint formed by a side-gabled main block with a two-story, gable-roof, rear (northwest) addition (added circa 1960, expanded circa 1995). A centered, exterior brick chimney extends above the southwest gable end of the main block. The roofline is accented by a wood frieze on the primary (southeast) elevation (historic, likely original) and gable-end returns (historic, likely original). The roof is sheathed in asphalt shingles throughout. The exterior of the dwelling is clad in vinyl siding. Windows are all vinyl-sash replacement units with aluminum storm windows set within vinyl surrounds. Inoperable, paneled vinyl shutters flank the windows on the primary, northeast, and southwest elevations. The primary elevation of the main block has symmetrical fenestration with eight-over-twelve windows and wood planters on the first floor, and eight-over-eight windows on the second floor. A single six-over-six window is featured in the center bay of the second floor. The central, primary entrance is sheltered by a pedimented portico with a sunburst motif (historic, likely original) supported by square wood columns (historic, likely original). Accessed by a brick and stone stoop, the entrance contains a modern paneled wood door, set within a wood surround with segmented sidelights and fluted Doric pilasters (historic, likely original). The southwest and northeast elevations of the main block both have symmetrical fenestration. Two wood quarter-circle windows (historic, likely original) flank the chimney in the southwest gable end of the main block. The first floor of the southwest elevation is sheltered by a full-length, shed-roof porch, supported by square wood posts with decorative wood brackets (historic, likely original). Beneath the porch, on either side of the chimney, there are wood screen doors. An arched, vinyl window is situated in the northeast gable end of the main block. The northeast elevation of the addition has asymmetrical fenestration with one vinyl-sash window on the first and second floors. A porch extends from the rear (northwest) elevation but is not readily visible from the public right-of-way. The dwelling stands on a parged foundation.

Character-defining elements of the dwelling include its massing, pedimented portico with sunburst motif, wood door surround with Doric pilasters, gable-end returns, wood quarter-circle windows in the southwest gable end of the main block, and southwest side porch.
