# PROPERTY REPORT

**Property Name:** 121 North Main Street **Ownership:** Private  
**Address:** 121 N Main ST **Apartment #:** **ZIP:** 08512

**Survey Name:** Cranbury Historic Sites Survey Phase III

**Organization:** Richard Grubb & Associates, Inc.

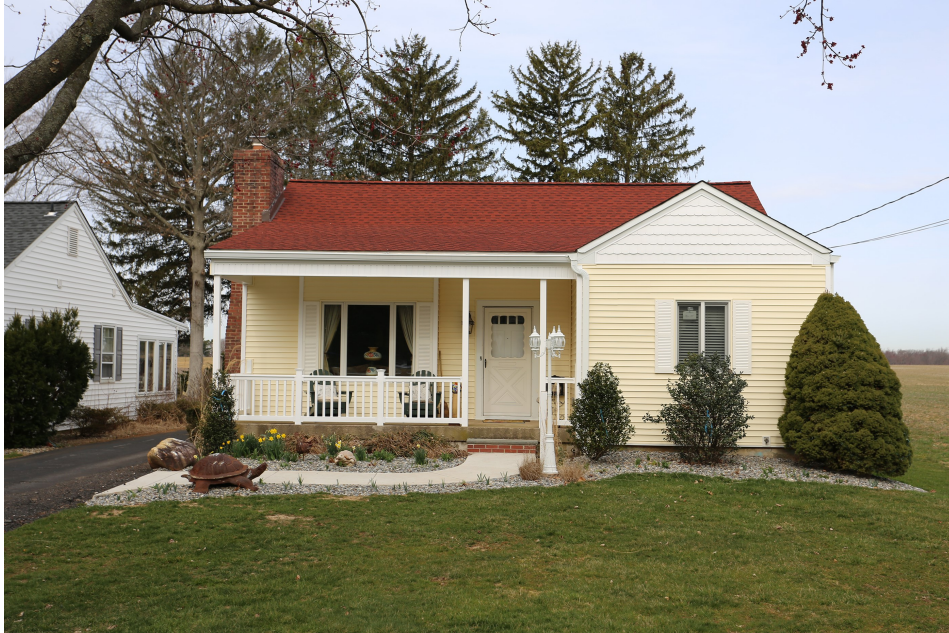
## Property Photo:

121 North Main Street is a one-story-tall, three-bay-wide, three-bay-deep, frame dwelling built circa 1948 in the Minimal Traditional style. The dwelling consists of a gable-and-wing main block with a one-bay-wide, front-gabled wing in the northern bay of the primary (southeast) elevation and another one-bay-wide, front-gabled wing extending from the southern bay of the rear (northwest) elevation. A shed-roof wing is located in the northern bays of the rear elevation and connects to a circa 1975, gable-roof rear addition. An exterior brick chimney extends above the southwest gable end of the main block. The roof is sheathed in asphalt shingles. The exterior of the dwelling is clad in vinyl siding. Windows are primarily grouped vinyl casement replacement units flanked by inoperable, vinyl louvered shutters. A shed-roof porch with a wood balustrade and square posts extends along the two southwestern bays of the primary elevation. The central, primary entrance features a paneled wood door with four lights and a metal storm door. A vinyl bay window is centered on the northeast elevation of the shed-roof wing. The rear elevation is not visible from the public right of way. The dwelling stands on a parged foundation.

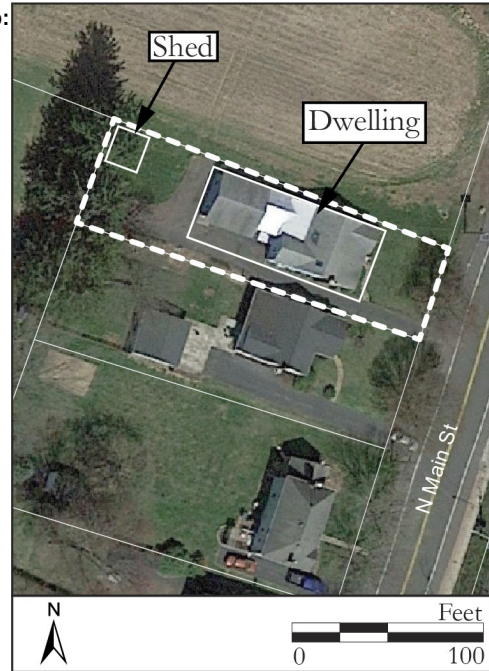
**Site Map:**

121 North Main Street is sited on a rectangular parcel (Block 25, Lot 25) located on the northwest side of North Main Street in Cranbury Township, Middlesex County, New Jersey. The dwelling is oriented with its primary elevation facing southeast and is set back approximately 40 feet from the road. An asphalt driveway extends along the southwest border of the property, bordered by a wood fence to

the northeast and northwest. Mature trees and shrubs are planted within close proximity to the dwelling. A cement path extends from the driveway to the primary entrance. The subject property is located in a residential neighborhood surrounded by properties dating from the mid-nineteenth to the late twentieth centuries.
