PROPERTY REPORT

Property Name: 121 North Main Street
Address: 121 N Main ST

Survey Name: Cranbury Historic Sites Survey Phase III

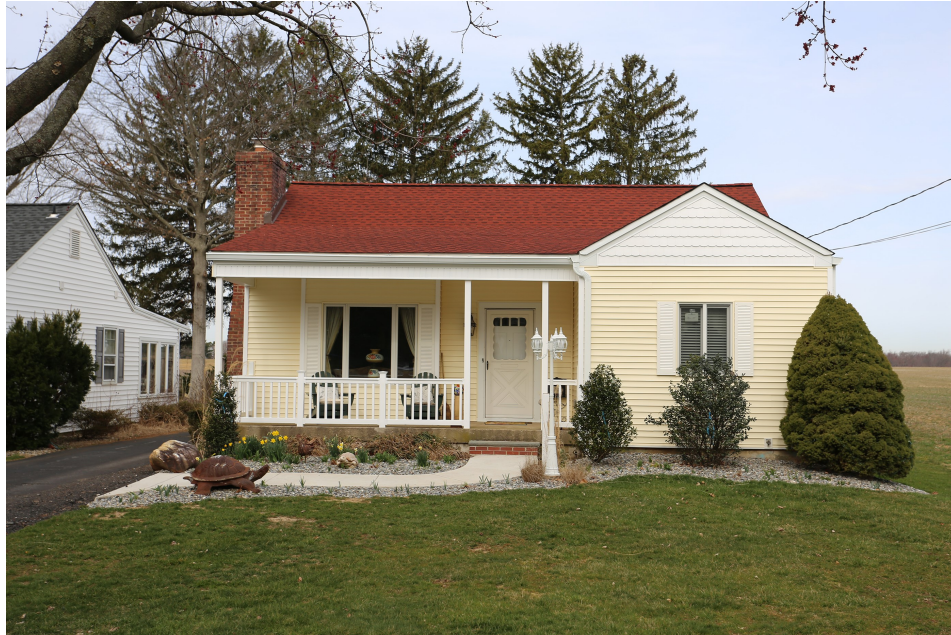
Property Photo:

121 North Main Street is a one-story-tall, three-bay-wide, three-bay-deep, frame dwelling built circa 1948 in the Minimal Traditional style. The dwelling consists of a gable-and-wing main block with a one-bay-wide, front-gabled wing in the northern bay of the primary (southeast) elevation and another one-bay-wide, front-gabled wing extending from the southern bay of the rear (northwest) elevation. A shed-roof wing is located in the northern bays of the rear elevation and connects to a circa 1975, gable-roof rear addition. An exterior brick chimney extends above the southwest gable end of the main block. The roof is sheathed in asphalt shingles. The exterior of the dwelling is clad in vinyl siding. Windows are primarily grouped vinyl casement replacement units flanked by inoperable, vinyl louvered shutters. A shed-roof porch with a wood balustrade and square posts extends along the two southwestern bays of the primary elevation. The central, primary entrance features a paneled wood door with four lights and a metal storm door. A vinyl bay window is centered on the northeast elevation of the shed-roof wing. The rear elevation is not visible from the public right of way. The dwelling stands on a parged foundation.
