## PROPERTY REPORT

**Property Name:** 119 North Main Street

**Survey Name:** Cranbury Historic Sites Survey Phase III

**Organization:** Richard Grubb & Associates, Inc.

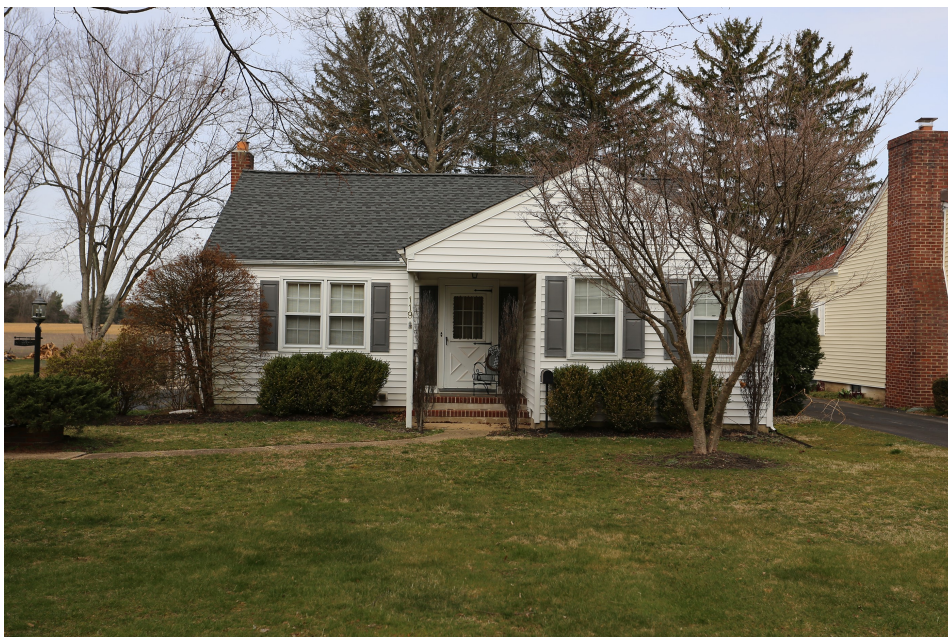
### Property Photo:

119 North Main Street is a one-story-tall, four-bay-wide, three-bay-deep, frame dwelling built circa 1948 in the Minimal Traditional style. The dwelling consists of a gable-and-wing main block with a two-bay-wide, front-gabled wing extending from the primary (southeast) elevation. Another one-bay-wide, gabled wing extends from the southern bay of the rear (northwest) elevation with a shed-roof enclosed porch located in the northern bays. An exterior brick chimney extends above the southwest gable end of the main block. The roof is sheathed in asphalt shingles. The exterior of the dwelling is clad in vinyl siding. Windows are primarily six-over-six, vinyl-sash, replacement units flanked by inoperable, vinyl paneled shutters on the primary, northeast, and southwest elevations. The central, primary entrance is sheltered by a porch with wood posts that extends from the front-gable wing. It contains a metal screen door with a multi-light, wood door and is accessed by a concrete and brick stoop. The northeast elevation of the enclosed porch contains grouped vinyl casement windows. The rear elevation is not visible from the public right of way. The dwelling stands on a parged foundation.
