PROPERTY REPORT

Property Name: 115 North Main Street
Address: 115 N Main ST

Survey Name: Cranbury Historic Sites Survey Phase III

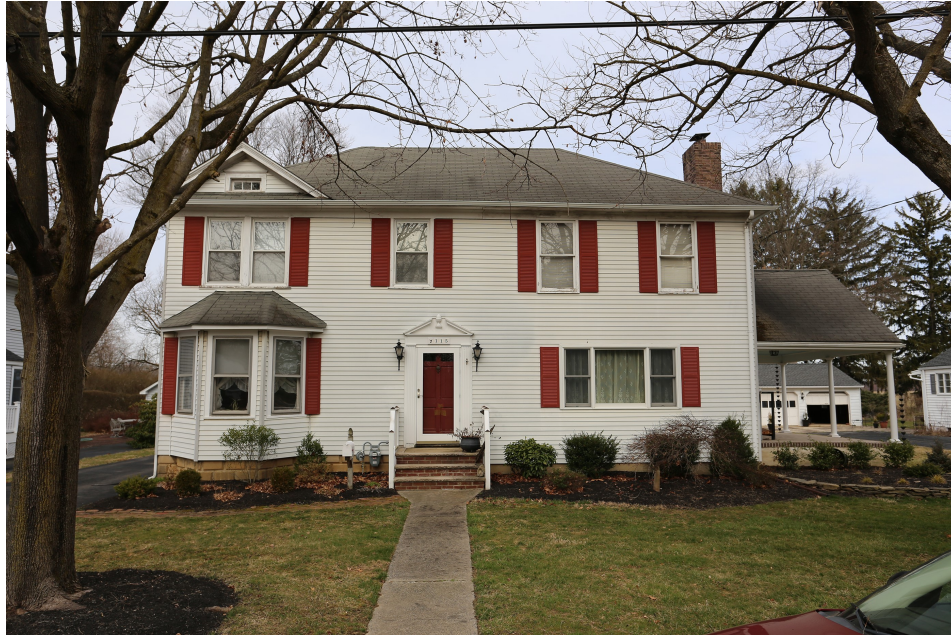
Property Photo:

115 North Main Street is a two-and-one-half-story-tall, four-bay-wide, two-bay-deep, frame dwelling built circa 1910 and expanded circa 1965. The original block of the dwelling consists of the southwest two bays, with the northeastern two bays representing the circa-1965 addition. The dwelling is capped by an asphalt-shingle, hipped roof. An interior brick chimney rises from the southwest roof slope and an exterior brick chimney is centered on the northeast elevation. A gabled dormer is located above the southwesternmost bay of the primary (southeast) elevation and features a three-light wood window in a wood surround (likely original). The exterior of the dwelling is clad in vinyl siding. Windows throughout are one-over-one, vinyl-sash replacement units, set within wood surrounds, some of which have molded wood lintels (likely original). The primary elevation has asymmetrical fenestration with inoperable, vinyl louvered shutters flanking the windows. In the southwesternmost bay, there is a semi-hexagonal projecting bay with a hipped roof. The central, primary entrance contains a wood paneled door with a metal storm door, set into a wood surround with fluted pilasters and a broken pediment. The entrance is accessed by a brick stoop with stone coping and wood railings. The southwest elevation has symmetrical fenestration with two windows on the first and second floors. The northeast elevation contains a secondary entrance with a metal storm door and is devoid of other openings. The first floor of the northeast elevation is sheltered by a gabled porch supported by vinyl Doric columns. The rear (northwest) elevation is not visible from the public right-of-way. The original block of the dwelling stands on a rusticated cast-stone foundation, while the circa-1965 addition stands on a concrete foundation.
