# PROPERTY REPORT

Property ID: **517698108**

**Property Name:** 163 North Main Street **Ownership:** Private  
**Address:** 163 N Main ST **Apartment #:** **ZIP:** 08512

**Survey Name:** Cranbury Historic Sites Survey Phase III

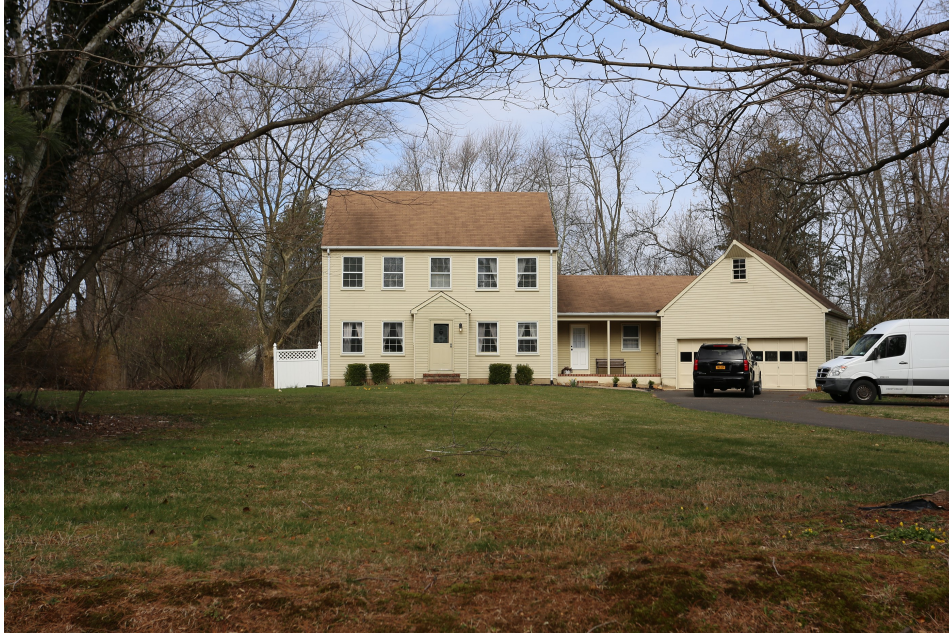
## Property Photo:

163 North Main Street is a two-story-tall, five-bay-wide, two-bay-deep, frame dwelling built circa 1981. The dwelling consists of a five-bay-wide, asymmetrical side-gable-roof main block with a side-gabled, one-story wing to the northeast that connects to a front-gabled, one-and-one-half-story, clipped-gable-roof garage. The roof is sheathed in asphalt shingles throughout. The exterior of the dwelling is clad in vinyl siding. Windows are primarily six-over-six, vinyl-sash units. An enclosed, front-gabled projection is centered on the main block's primary (southeast) elevation and contains the primary entrance, accessed by a brick and concrete stoop. The material of the door in the primary entrance is obscured by a glazed metal storm door. A tripartite, fixed vinyl window is located in the northwest bay of the southwest elevation. The northeast wing features a concrete and brick porch with an overhanging roof supported by a square wood post. A secondary entrance is located in the southern bay of the northeast wing and contains a vinyl door. The porch also shelters a vinyl door that leads to the attached garage on its southwest elevation. The primary elevation of the garage is symmetrical and contains two metal panel roll-top doors with glazing along with a single four-over-over, vinyl-sash window in the gable peak. The rear (northwest) elevation is not visible from the public right-of-way. The dwelling stands on a concrete foundation

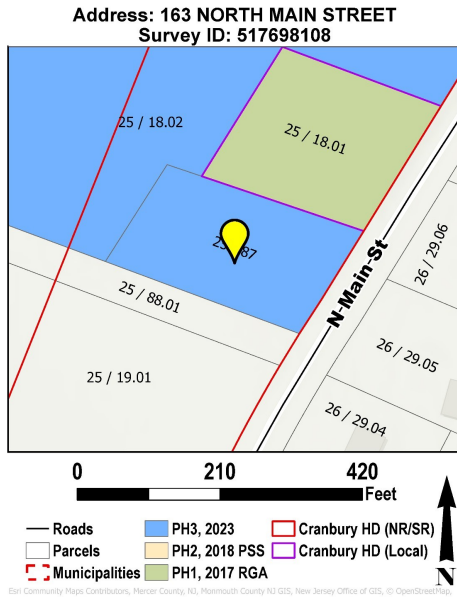
Site Map:

163 North Main Street is sited on a rectangular parcel (Block 25, Lot 87) located on the northwest side of North Main Street in Cranbury Township, Middlesex County, New Jersey. The dwelling is oriented with its primary elevation facing southeast and is set back approximately 120 feet from the road. An asphalt driveway extends from northwest from North Main Street to the attached garage. A paved stone path extends from the driveway to the primary entrance. Mature trees and shrubs are planted within close proximity to the dwelling. The subject property is located in a residential neighborhood surrounded by properties dating from the mid-nineteenth to late twentieth centuries.
