PROPERTY REPORT

Property Name: George Farr Farm

Address: 158 N Main ST

Survey Name: Cranbury CLG Survey 2017

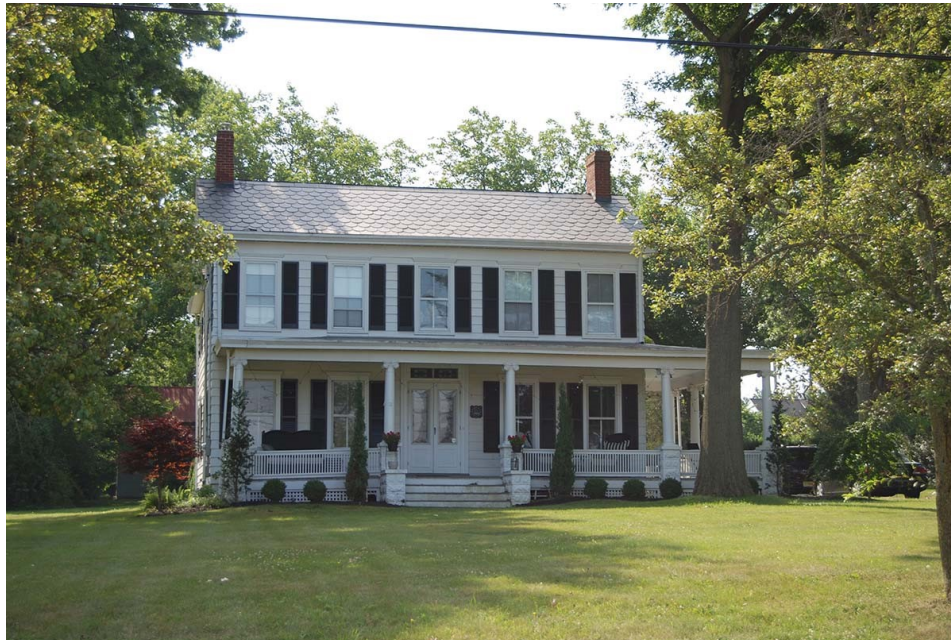
Property Photo:

The George Farr Farm at 158 North Main Street is a two-story tall, five-bay wide, two-bay deep, frame private residence constructed circa 1865 in a vernacular style with the appearance of a formal center hall plan. The dwelling consists of a rectangular, side-gabled main block, a two-story ell and a two-story hipped roof addition to the rear (southwest), a one-story shed roof addition extending from the southwest elevation of the ell, and a one-story enclosed porch extending from the southeast elevation of the ell. The roof is sheathed with slate shingles on the main block and asphalt shingles on the rear additions. Interior brick chimneys pierce the roof at the northeast and southwest gable ends of the main block. The dwelling features a molded wood cornice with a return cornice at the northeast and southwest gable ends. The exterior of the dwelling is clad in aluminum siding on all elevations. Windows on the front elevation are two-over-two, double-hung, replacement wood-sash windows with molded surrounds and molded wood lintels. Inoperable louvered shutters flank the windows. The central entrance consists of paired one-light, one-panel doors topped by a segmented, rectangular transom with a floral stained glass design. The doors are set within a molded wood surround. A one-story, hipped roof porch that wraps around from the front elevation to the southwest elevation shelters the entrance. The porch has Ionic columns set on rusticated concrete block piers and a low railing with thin wood balusters. A narrow louvered window with a molded wood lintel sits in the southwest gable end of the main block. Windows on the southwest elevation of the main block and the rear ell are two-over-two, double-hung, replacement wood-sash windows with molded wood surrounds, molded wood lintels, and inoperable louvered shutters. The enclosed porch on the first floor of the rear ell has metal screen windows and a metal screen door. The rear elevation is not visible from the public right-of-way. A narrow louvered

window sits in the northeast gable end of the main block. Windows on the northeast elevation of the main block, the rear ell, and the two-story hipped roof addition are two-over-two, double-hung, replacement wood-sash windows with molded wood surrounds, molded wood lintels, and inoperable louvered shutters. Character-defining elements of the dwelling include the interior gable end brick chimneys and the one-story wraparound porch with Ionic columns.
