## PROPERTY REPORT

**Property Name:** 110 North Main Street

**Survey Name:** Cranbury CLG Survey 2017

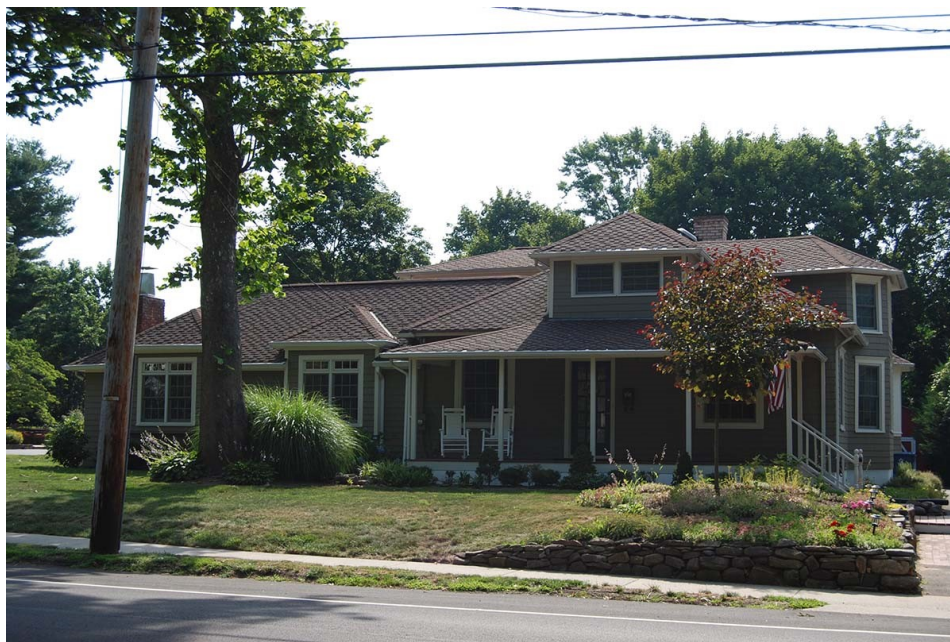
### Property Photo:

110 North Main Street is a heavily altered Bungalow that faces west. The multiple additions and alterations have given the house a rambling appearance and have greatly undermined the building's historic appearance. It is comprised of a one-and-a-half story, three-bay core that has a two-story octagonal bay to the south, a large one-and-a-half story rear extension, and a one-and-a-half story wing extending to the north. The core was constructed circa 1915. The roof of the entire house is clad with asphalt shingles and features two interior brick chimneys. On the front of the core, a hipped-roof dormer has a paired six-over-six replacement window with vinyl sashes. The eaves are clad with vinyl siding. The exterior of the dwelling is clad in wood shingles. Fenestration consists of replacement vinyl-sash windows with multiple inset lights. The front porch extends along the entire front of the core; it has a hipped roof supported by five thin square columns (replacement). The entrance is a single French door with multiple inset lights within a molded wood surround. The south elevation of the core has the same cladding as the main elevation. A two-story octagonal bay also has asphalt shingles on the roof and wood shingled walls; the front panel of the bay features a paired (replacement) window on the second floor and a single-light window on the first floor; the side panels feature replacement six-over-six vinyl sash replacement windows. The rear extension is clad with stucco and features a one-story octagonal bay with multi-light windows. The wing off the north elevation of the core dominates its elevation. The wing has a hipped roof with an engaged exterior brick chimney on its north wall. Two through-the-cornice wall dormers protrude slightly from the wall surface and contain paired, multi-light windows. The north elevation of the wing has no wall openings. The wing has a concrete foundation. Character-defining elements of the building include hipped roof dormers and multiple projecting bays.

The 1989 Heritage Studies survey identified 110 North Main Street as a contributing resource to the Cranbury Historic District. However, the subject dwelling has since undergone extensive alterations. Therefore, RGA recommends 110 North Main Street as a non-contributing resource to the district.
