PROPERTY REPORT

Property Name: 112 North Main Street
Address: 112 N Main ST

Survey Name: Cranbury Historic Sites Survey Phase III

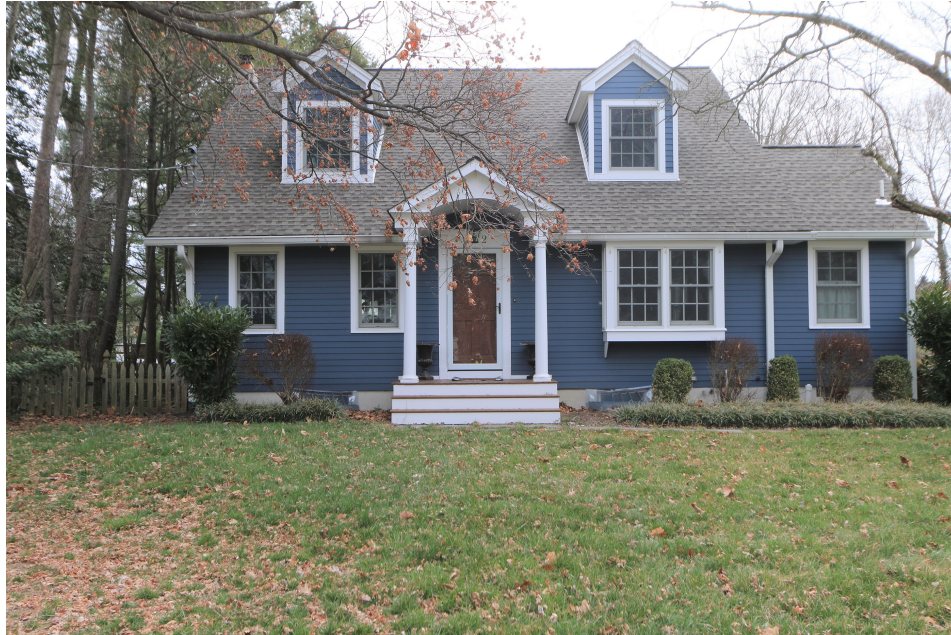
Property Photo:

112 North Main Street is a one-and-one-half-story-tall, four-bay-wide, frame dwelling constructed circa 1950 in the Minimal Traditional style. The dwelling consists of a side-gabled main block with a one-story, side-gable southwest wing. The roof of the main block is interrupted by symmetrically placed, gable-roof dormers on the primary (northwest) slope (added circa 2004) and a full length, shed-roof dormer (added circa 2004) on the southeast slope. The roof, accented by overhanging eaves, is covered by asphalt shingles throughout. An off-center, exterior, concrete block chimney pierces the northeast gable end. The exterior of the dwelling is clad in wood clapboard siding. Windows are all single and paired, six-over-six or eight-over-eight, vinyl-sash replacement units. The primary elevation has asymmetrical fenestration with six-over-six, vinyl-sash windows in the two northernmost bays and a square bay window in the southernmost bay. Windows on this elevation are all set within wood surrounds (likely original). The central, primary entrance contains a paneled wood door (likely original) with a metal storm door, set within a wood surround with a slightly molded lintel (likely original). The entrance is sheltered by a front-gabled portico with wood Doric columns. Both the northeast and southwest elevations of the dwelling have asymmetrical fenestration. The southwest wing contains a six-over-six, vinyl-sash window on its northwest elevation and a paired vinyl-sash windows centered in its southwest elevation. The rear elevation is not visible from the public right-of-way. The dwelling stands on a concrete foundation.

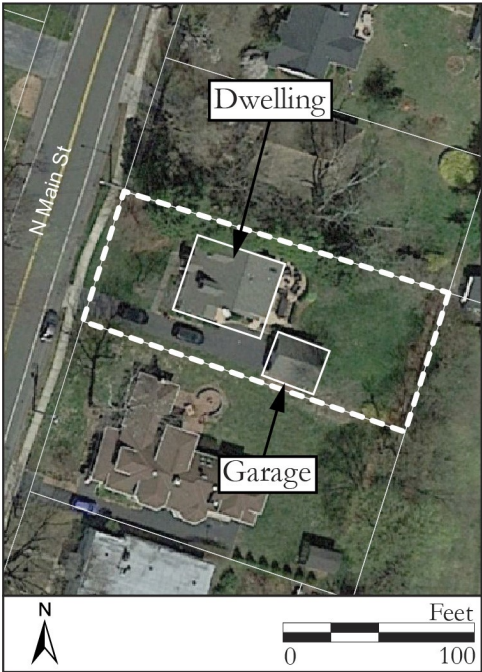
Site Map:

A one-story-tall, two-bay-wide, concrete block garage, built circa 1950, stands approximately 13 feet southeast of the dwelling. It has an asphalt-shingle, front-gabled roof with wood clapboard siding in the gable end. The primary (northwest) elevation contains two wood panel roll-top doors (likely original). Both the southwest and northeast elevations have symmetrical fenestration with (likely original). The rear (southeast) elevation is not visible from the public right-of-way.
