PROPERTY REPORT

Property Name: 120 North Main Street

Address: 120 N Main ST

Survey Name: Cranbury Historic Sites Survey Phase III

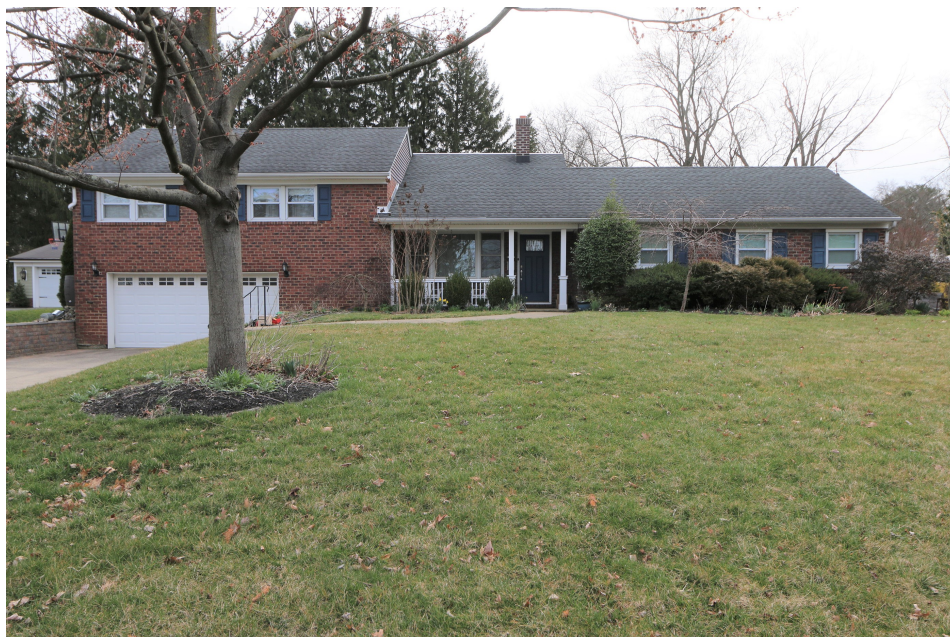
Property Photo:

120 North Main Street is a two-story-tall, seven bay-wide, two-bay-deep, brick, Tri-Level Split dwelling constructed circa 1955. The dwelling consists of a partially embanked, side-gabled main block and a rear (southeast) gabled addition (built circa 2012). Asphalt shingles cover the roof throughout. The exterior of the dwelling is clad in brick laid in running bond, with vinyl siding in the gable ends. An interior brick chimney pierces the roof ridge of the main block. Windows generally consist of single and grouped, vinyl-sash replacement units with inoperable, louvered vinyl shutters flanking the windows on the primary (northwest) elevation. The two central bays on the primary elevation are recessed, forming an integrated porch supported by square wood posts on square wood pedestals wood posts and a simple wood balustrade. A picture window flanked by one-over-one windows is located in the northern bay beneath the porch and the primary entrance is located in the southern bay. The entrance contains a modern wood panel door with a rectangular light. Situated at the ground level in the northernmost bay of the main block is a single garage bay with a vinyl panel roll-top door. The northeast and southwest elevations have symmetrical fenestration. The rear elevation and the circa-2012 rear addition are not visible from the public right-of-way.
