## PROPERTY REPORT

**Property Name:** 122 North Main Street  
**Address:** 122 N Main ST

**Survey Name:** Cranbury Historic Sites Survey Phase III

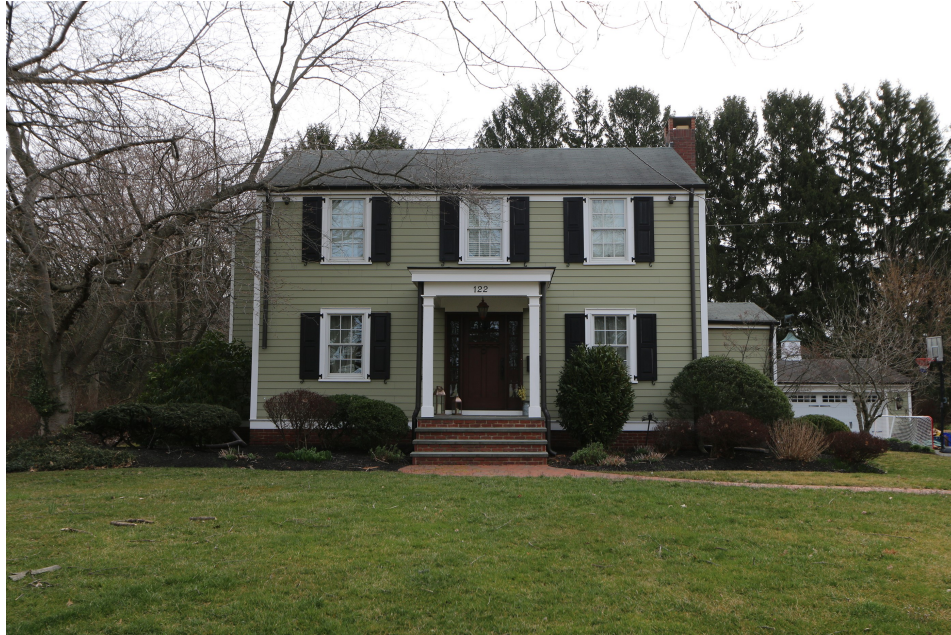
### Property Photo:

122 North Main Street is a two-story-tall, three bay-wide, two-bay-deep, frame dwelling constructed circa 1950 in the Colonial Revival style. The dwelling consists of a side-gabled main block with a one-story, side-gabled southwest wing and a two-story, cross-gable northeast addition (constructed circa 2017). Asphalt shingles covers the roof throughout. An exterior, brick chimney is centered on the southwest elevation of the main block. The dwelling is clad in vinyl siding. Windows are generally six-over-six or one-over-one, vinyl-sash replacement units flanked by operable, paneled wood shutters. The primary (northwest) elevation of the main block has symmetrical fenestration with a central primary entrance, containing a six-light, paneled wood door with segmented sidelights. Sheltering the entrance is a one-bay-wide, flat-roof portico with square wood posts and a brick stoop with stone coping. The northeast and southwest elevations of the main block both have asymmetrical fenestration. The southwest wing contains grouped vinyl-sash windows centered on its southwest elevation, while its northwest elevation is devoid of openings. The northeast addition has asymmetrical fenestration on its northeast elevation, with a shed-roof bay window pierces the east bay on the first floor. The rear (southeast) elevation was not visible from the public right-of-way. The dwelling stands on a brick foundation.

A circa-1950 one-story-tall, one-bay-wide, frame garage stands southeast of the dwelling. The garage is capped by a side-gabled, asphalt-shingle roof with a small wood cupola with a weathervane. The exterior of the garage is clad in vinyl siding. The primary (northwest) elevation contains a paneled wood, roll-top door with faux strap hinges.
