PROPERTY REPORT

Property Name: 126 North Main Street

Survey Name: Cranbury Historic Sites Survey Phase III

Organization: Richard Grubb & Associates, Inc.

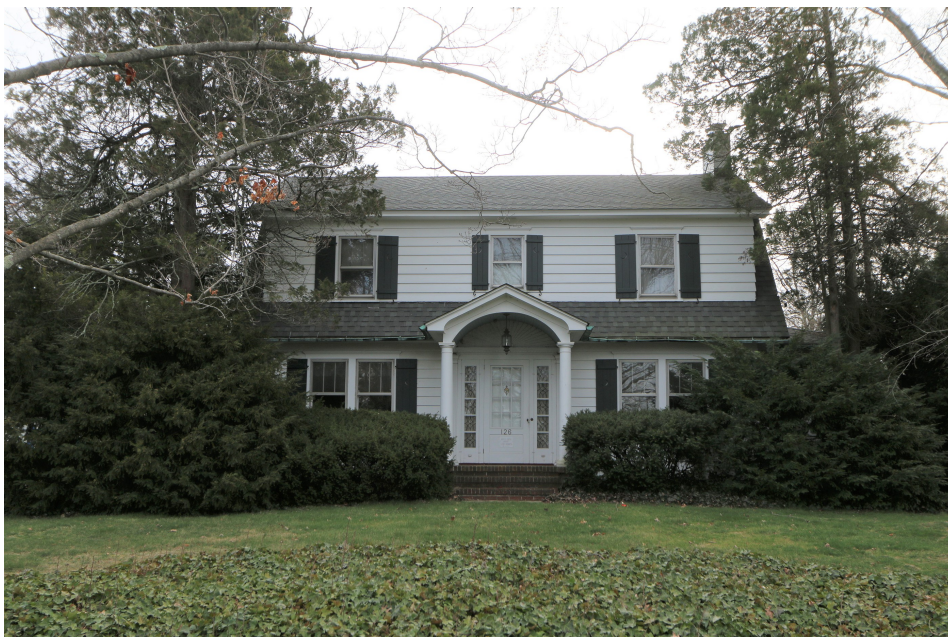
Property Photo:

126 North Main Street is a two-story-tall, three-bay-wide, two-bay-deep, frame dwelling constructed circa 1928 in the Dutch Colonial Revival style. The dwelling consists of a gambrel-roof main block with a one-story, hipped-roof, southwest wing; a one-story, hipped-roof, northeast porch; and a one-story, shed-roof addition on the rear (southeast) elevation (added circa 1965). Full-length, shed-roof dormers interrupt both roof slopes of the main block. Asphalt shingles cover the roof throughout. The roof of the main block is accented by overhanging eaves. An exterior brick chimney is centered on the southwest elevation. The exterior of the dwelling is clad in wood clapboard siding. The primary (northwest) elevation has symmetrical fenestration with paired, three-over-one, wood-sash windows (historic, likely original) on the first floor and second floor, flanked by wood batten shutters that feature crescent moon cutouts and metal shutter dogs (historic, likely original). Windows on this elevation are all set within wood surrounds with slightly molded lintels (historic, likely original) with metal storm windows. The central, primary entrance contains a 12-light, wood door (historic, likely original), set within a wood surround with a dentillated lintel, wood transom with a sunburst motif, segmented sidelights and fluted wood pilasters (historic, likely original). The entrance is sheltered by a front-gable portico with wood Doric columns (possibly historic). Both the northeast and southwest elevations of the dwelling have asymmetrical fenestration and are mostly obscured by heavy vegetation. A central, secondary entrance is visible on the northeast porch, but materials are unclear. The rear addition and rear elevation was not visible from the public right-of-way.

Character-defining elements of the dwelling consist of its massing, gambrel roof with shed-roof dormers, wood-sash windows with wood surrounds, and 12-light wood door with a wood surround.
