PROPERTY REPORT

Property Name: 140 North Main Street
Address: 140 N Main ST

Survey Name: Cranbury Historic Sites Survey Phase III

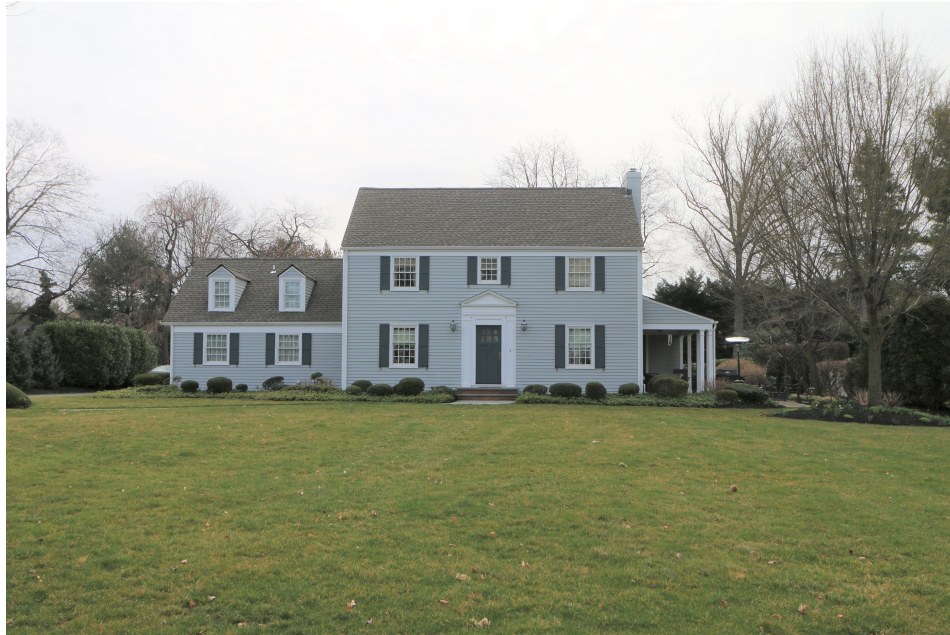
Property Photo:

140 North Main Street is a two-and-one-half-story-tall, three-bay-wide, two-bay-deep, frame dwelling constructed circa 1945 in the Colonial Revival style. The dwelling consists of a side-gabled main block with a one-and-one-half-story, side-gable, northeast wing and a one-story, shed-roof, rear (southeast) addition (added circa 1995). Asphalt shingles cover the roof throughout. A shed-roof dormer interrupts the main block's rear roof slope and the northeast wing features two gabled dormers on the primary (northwest) slope and a full-length, shed-roof dormer on the rear slope. An exterior, brick chimney is centered on the southwest elevation of the main block. The exterior of the dwelling is clad in wood clapboard siding. Windows on the main block are generally eight-over-twelve, vinyl-sash replacement units on the first floor and eight-over-eight vinyl-sash units on the second floor, all set within wood surrounds (likely original). Operable louvered wood shutters flank most of the windows on the main block's primary, northeast, and southwest elevations. The primary elevation has symmetrical fenestration with a six-over-six vinyl window centered on the second floor. The central primary entrance contains a six-light, wood cottage door, set within a wood surround with unfluted pilasters beneath a pediment (likely original). The southwest elevation of the main block has symmetrical fenestration. The first floor is sheltered by a shed-roof porch with paired, square wood columns (likely original). The northeast elevation of the main block is partially obscured by the northeast wing features a single six-over-six window in the gable peak. The northeast wing features symmetrically placed, eight-over-eight, vinyl-sash replacement window with operable louvered wood shutters on the primary and northeast elevations on the first floor. Six-over-six, vinyl-sash replacement windows are situated in the dormers. A secondary entrance to the rear addition is located under the southwest porch, but it is obscured from the public right-of-way. The rear elevation was not visible from the public right-of-way.
