PROPERTY REPORT

Property Name: 144 North Main Street
Address: 144 N Main ST

Survey Name: Cranbury Historic Sites Survey Phase III

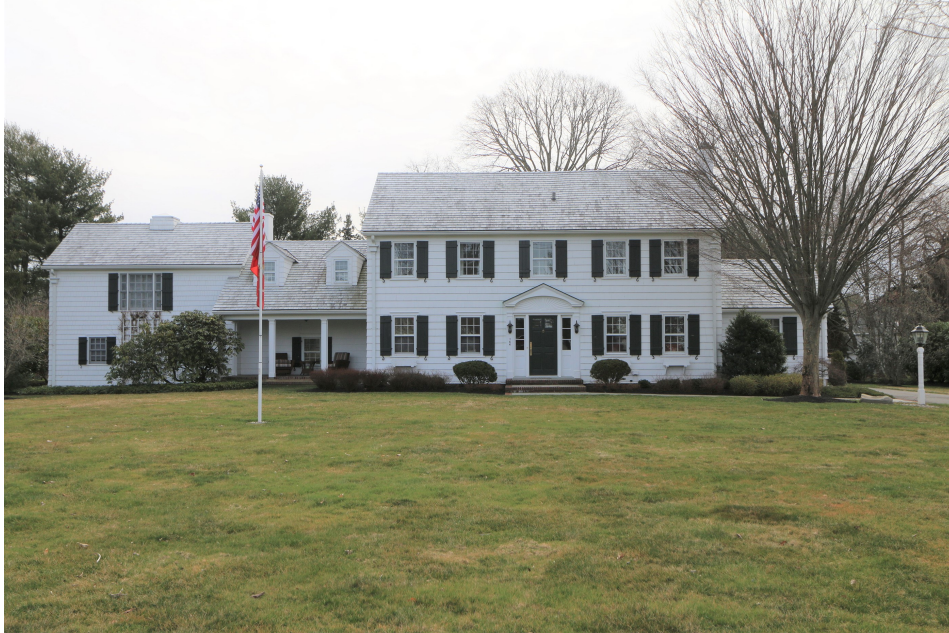
Property Photo:

144 North Main Street is a two-story-tall, five-bay-wide, two-bay-deep, frame dwelling constructed circa 1936 in the Colonial Revival style. The dwelling consists of a side-gabled main block with a one-story tall, two-bay-wide, side-gabled addition to the southwest (added circa 1960); a one-and-one-half-story-tall, one-bay-wide, side-gabled addition to the northeast (added circa 1960); and a two-story-tall, side-gabled addition on the northeast elevation of the northeast addition (added circa 1990) that connects the dwelling to a circa-1960, one-and-one-half-story-tall, frame garage. Wood shingles cover the roof throughout. An exterior, brick chimney is centered on the southwest elevation of the main block, and an interior brick chimney extends from the junction of the circa-1960 northeast addition and the circa-1990 northeast addition. and the two-story, side-gable addition. The exterior of the dwelling is clad in wood shingles. Windows vary between double-hung, wood-sash windows on the main block and additions, interspersed with vinyl-sash replacement units. Wood batten shutters flank the windows on the primary (northwest), northeast, and southeast elevations. The primary elevation of the main block has symmetrical fenestration, with six-over-six, wood-sash windows set into wood surrounds with slightly molded lintels (historic, likely original). The central, primary entrance contains a replacement paneled wood door, set into a wood surround with segmented sidelights and unfluted pilasters, topped by a pediment with a sunburst motif (historic, likely original). The northeast and southwest elevations of the main block are partially obscured by additions, and contain six-over-six, wood-sash windows on the first and second floors. The southwest gable end contains a four-light, fixed wood window (historic, likely original), while the northeast gable end contains a six-over-six, wood-sash window. On the northeast elevation of the main block, there is a secondary entrance with a paneled wood door and a wood storm door (possibly historic).

The circa-1960, southwest addition has an eight-over-eight, vinyl-sash window on its primary elevation, with a tripartite, vinyl-sash window on the southwest elevation and a vinyl-sash window in the southwest gable end. The circa-1960, northeast addition contains two gabled dormers on its primary (northwest) slope, and an incorporated porch with square, wood columns that shelters an eight-over-eight, vinyl-sash window on the primary elevation. The primary elevation of the circa-1990, northeast addition contains vinyl-sash windows on the first floor with a tripartite, vinyl-sash window centered on the second floor. Its northeast elevation has symmetrical fenestration with vinyl-sash windows. The foundation of the dwelling is not visible. The rear (southeast) elevation of the dwelling is not visible from the public right-of-way.
