PROPERTY REPORT

Property Name: 128 North Main Street
Address: 128 N Main ST

Survey Name: Cranbury Historic Sites Survey Phase III

PROPERTY REPORT: PHOTO CONTINUATION SHEET

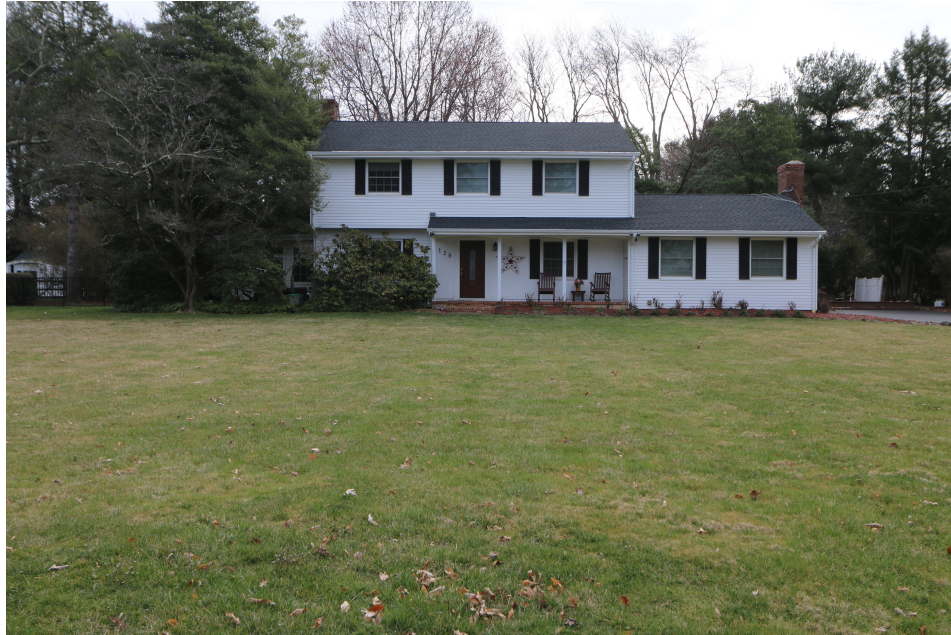
Property Photo:

128 North Main Street is a two-story-tall, three-bay-wide, two-bay-deep, frame dwelling constructed circa 1958. The dwelling consists of a side-gabled main block with a one-story, side-gabled, southwest wing, and a one-story, side-gabled, northeast wing. The roof throughout is covered by asphalt shingles and accented by overhanging eaves. Exterior brick chimneys are centered on the northeast elevation of the main block and the southwest elevation of the southwest wing. The exterior of the dwelling is clad in vinyl siding. Windows are all six-over-six or eight-over-eight, vinyl-sash, replacement units. Inoperable, vinyl louvered shutters flank the windows on the primary (northwest) and southeast elevations of the main block and southwest wing. Located in the center bay of the main block, the primary entrance contains a paneled wood door with a single rectangular light. A one-story, shed-roof porch shelters the two southernmost bays of the main block, supported by square, wood posts. Fenestration on the northeast elevation of the main block and the northeast wing are obscured by coniferous trees. The southwest wing has symmetrical fenestration on the primary and southeast elevations. A walkway covered by a gable roof connects the rear (southeast) elevation of the wing to a circa-1965 garage. The rear elevation of the dwelling was not visible from the public right-of-way.

A one-story-tall, two-bay-wide, frame garage, built circa 1965, sits approximately 8 feet southeast of the dwelling, connected by a covered walkway. The side-gabled roof is clad in asphalt shingles and accented by overhanging eaves. Vertical wood paneling covers the exterior. The primary (southwest) elevation contains two vinyl paneled, roll-top garage doors. The rear (northeast) and the southeast elevations are not visible from the public right-of-way.
