PROPERTY REPORT

Property Name: 103 Plainsboro-Cranbury Road **Ownership:** Private
Address: 101 PLAINSBORO RD **Apartment #:** **ZIP:** 08512

Survey Name: Cranbury Local Historic District Survey 2018

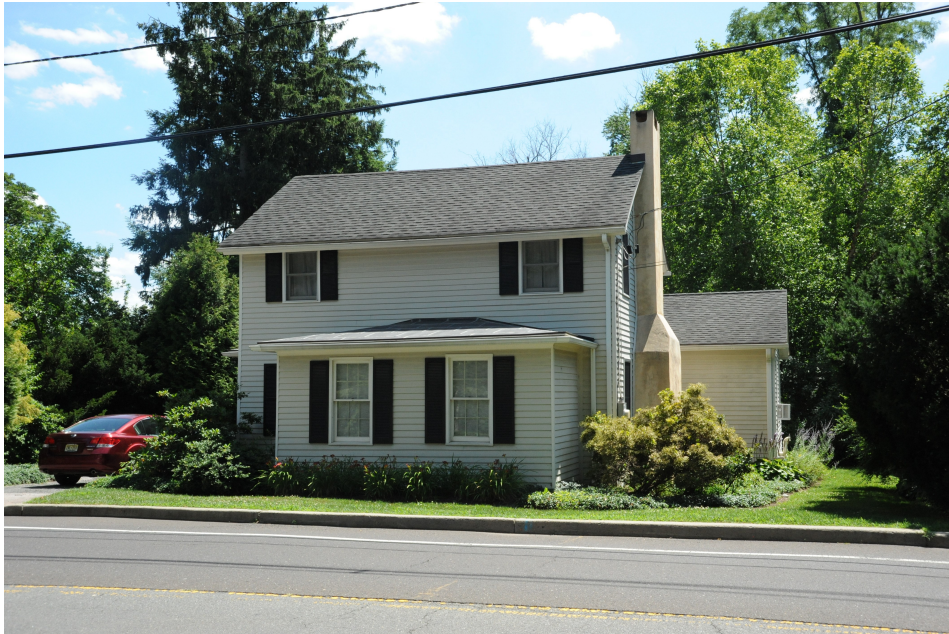
Property Photo:

The 2-story, side gable-roofed, rectangular-plan main block of this clapboard-clad dwelling on a covered foundation is 3 bays wide and 2 bays deep and is fronted on the northeast by a 1-story, hipped-roofed enclosed porch volume in the northwest bays and backed on the southwest by a 2-story, gable-roofed secondary volume. The rear volume is in turn backed by a 1-story, gable-roofed rear el. A 1-story, gable-roofed side volume is on the northwest side. A 1-story, hipped-roofed entry porch is located in the southwest bay of the southeast elevation of the main block. A shed-roofed, added oriel projects from the northeast bay. The roofs are predominantly clad in asphalt shingle except for the front volume and side porch, which are composite. The oriel has a standing-seam metal roof. The windows predominantly have 1/1 replacement sash. An exterior, stuccoed chimney is centered on the gable end of the main volume on the northwest elevation. The side porch provides access to the primary entrance and includes replaced turned posts, a replaced rail with square-plan balusters, and an added spindle frieze. The primary entrance is located in the southwest bay of the main block and includes a replaced door. The adjacent oriel is lighted by a double window. 2 single windows light the second floor. The rear volume is lighted by a double window on the first floor and a single window on the second. The northeast, street-facing elevation is lighted on the first floor by 1 window in the main block and 2 windows in the projecting volume, with a window in each of the outer bays of the second floor. The

northwest, side and southwest, rear elevations are not visible from the public right-of-way. A 1 ½-story, gable-roofed, frame garage with siding doors and a historic 6-light window is located to the southeast of the residence.

101 Plainsboro Road is a non-contributing property in the Cranbury Historic District by virtue of the extensive alterations visible from the public right-of-way, which include alterations to the historic massing, alterations to the historic fenestration patterns, the replacement of the majority of the window sash, the relocation of the primary entrance to the side elevation, and the addition of the oriel and large side porch.
