## PROPERTY REPORT

**Property Name:** 103 Plainsboro-Cranbury Road

**Survey Name:** Cranbury Local Historic District Survey 2018

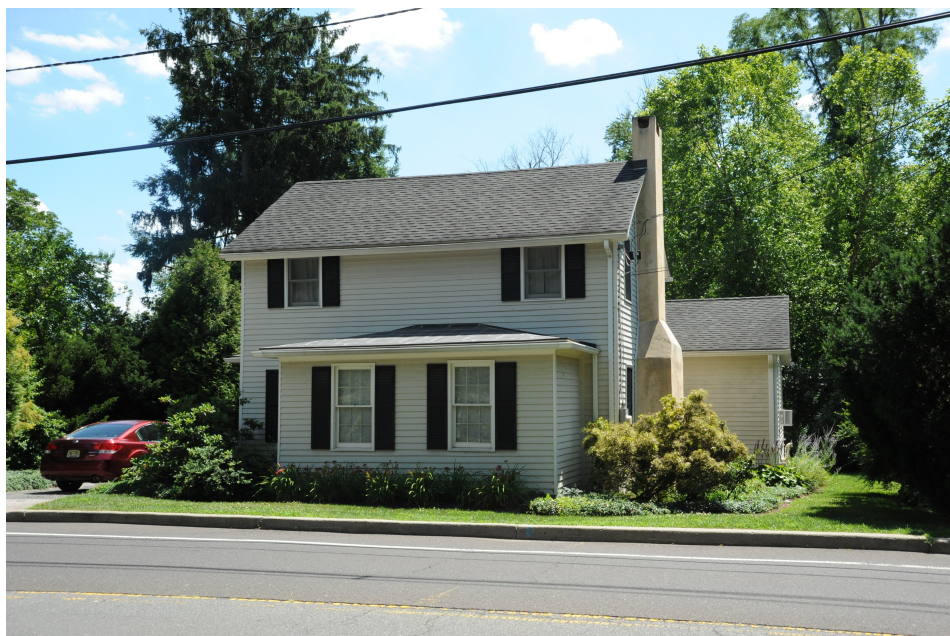
### Property Photo:

The 2-story, side gable-roofed, rectangular-plan main block of this clapboard-clad dwelling on a covered foundation is 3 bays wide and 2 bays deep and is fronted on the northeast by a 1-story, hipped-roofed enclosed porch volume in the northwest bays and backed on the southwest by a 2-story, gable-roofed secondary volume. The rear volume is in turn backed by a 1-story, gable-roofed rear el. A 1-story, gable-roofed side volume is on the northwest side. A 1-story, hipped-roofed entry porch is located in the southwest bay of the southeast elevation of the main block. A shed-roofed, added oriel projects from the northeast bay. The roofs are predominantly clad in asphalt shingle except for the front volume and side porch, which are composite. The oriel has a standing-seam metal roof. The windows predominantly have 1/1 replacement sash. An exterior, stuccoed chimney is centered on the gable end of the main volume on the northwest elevation. The side porch provides access to the primary entrance and includes replaced turned posts, a replaced rail with square-plan balusters, and an added spindle frieze. The primary entrance is located in the southwest bay of the main block and includes a replaced door. The adjacent oriel is lighted by a double window. 2 single windows light the second floor. The rear volume is lighted by a double window on the first floor and a single window on the second. The northeast, street-facing elevation is lighted on the first floor by 1 window in the main block and 2 windows in the projecting volume, with a window in each of the outer bays of the second floor. The

northwest, side and southwest, rear elevations are not visible from the public right-of-way. A 1 ½-story, gable-roofed, frame garage with siding doors and a historic 6-light window is located to the southeast of the residence.

101 Plainsboro Road is a non-contributing property in the Cranbury Historic District by virtue of the extensive alterations visible from the public right-of-way, which include alterations to the historic massing, alterations to the historic fenestration patterns, the replacement of the majority of the window sash, the relocation of the primary entrance to the side elevation, and the addition of the oriel and large side porch.
