PROPERTY REPORT

Property Name: 92 North Main Street

Survey Name: Cranbury CLG Survey 2017

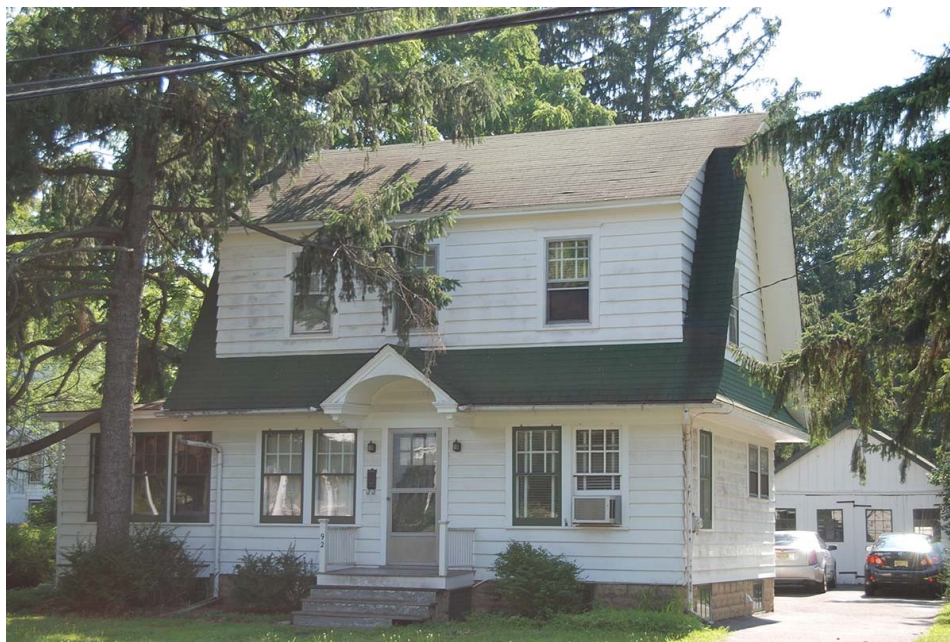
Property Photo:

92 North Main Street is a two-story, three-bay, two-pile, frame Dutch Colonial Revival residence constructed circa 1925. The gambrel roof is sheathed with asphalt shingles and includes a return cornice on the end walls. The shed dormer occupies most of the slope of the roof below the curb; it is clad with asphalt shingles and wood beveled siding. Three six-over-one wood sash windows (possibly original) are arranged asymmetrically on the dormer. An exterior brick chimney pierces the north end of the roof. The exterior of the dwelling is clad in wood beveled siding. Fenestration consists of six-over-one, double hung, wood-sash windows (possibly original); those on the main elevation are paired. The central entrance is a six light, two-panel wood cottage door with an exterior wood screen door; it opens below an arcuated gable that extends from the roof eaves. The front stoop has a low railing along its sides and frame steps leading down to the grade of the front lawn. The foundation was built with rusticated cast stone with horizontal basement windows.

The south gambrel end repeats the cladding materials of the main elevation. A paired window is located in the peak of the gambrel. On the first floor below the return cornice, a six-over-one wood sash window (possibly original) is located west of a smaller paired window. Two horizontal basement windows are located in the cast stone foundation. The north elevation repeats the cladding of the main elevation. This elevation, which is difficult to document due to the mature vegetation, is the location of the house's sole addition, a one-story, one-bay section with a hipped roof clad with asphalt shingles, frame walls, and bands of six-over-one wood sash windows. The section has a concrete foundation.
