PROPERTY REPORT

Property Name: 92 North Main Street **Ownership:** Private
Address: 92 N Main ST **Apartment #:** **ZIP:** 08512

Survey Name: Cranbury CLG Survey 2017

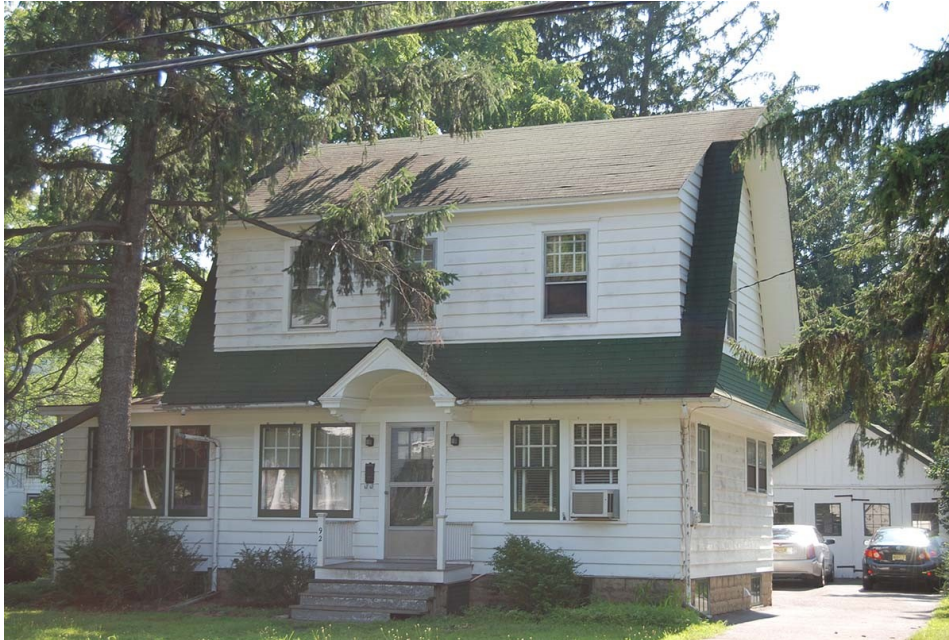
Property Photo:

92 North Main Street is a two-story, three-bay, two-pile, frame Dutch Colonial Revival residence constructed circa 1925. The gambrel roof is sheathed with asphalt shingles and includes a return cornice on the end walls. The shed dormer occupies most of the slope of the roof below the curb; it is clad with asphalt shingles and wood beveled siding. Three six-over-one wood sash windows (possibly original) are arranged asymmetrically on the dormer. An exterior brick chimney pierces the north end of the roof. The exterior of the dwelling is clad in wood beveled siding. Fenestration consists of six-over-one, double hung, wood-sash windows (possibly original); those on the main elevation are paired. The central entrance is a six light, two-panel wood cottage door with an exterior wood screen door; it opens below an arcuated gable that extends from the roof eaves. The front stoop has a low railing along its sides and frame steps leading down to the grade of the front lawn. The foundation was built with rusticated cast stone with horizontal basement windows.

The south gambrel end repeats the cladding materials of the main elevation. A paired window is located in the peak of the gambrel. On the first floor below the return cornice, a six-over-one wood sash window (possibly original) is located west of a smaller paired window. Two horizontal basement windows are located in the cast stone foundation. The north elevation repeats the cladding of the main elevation. This elevation, which is difficult to document due to the mature vegetation, is the location of the house's sole addition, a one-story, one-bay section with a hipped roof clad with asphalt shingles, frame walls, and bands of six-over-one wood sash windows. The section has a concrete foundation.

Character defining elements of the dwelling include its gambrel with shed roof dormer.
