## PROPERTY REPORT

Property ID: **397015518**

**Property Name:** 86 North Main Street **Ownership:** Private  
**Address:** 86 N Main ST **Apartment #:** **ZIP:** 08512

**Survey Name:** Cranbury CLG Survey 2017

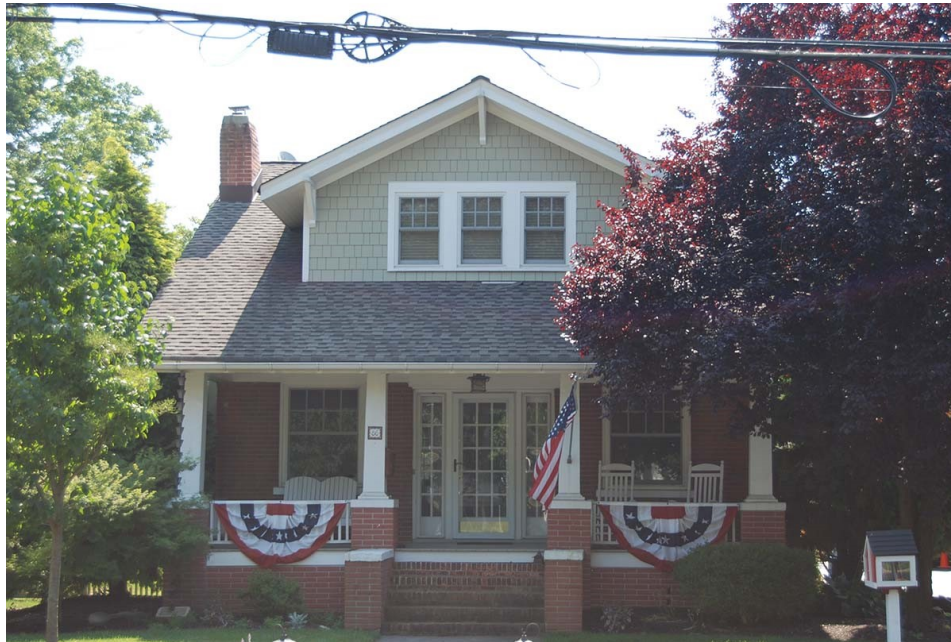
### Property Photo:

86 North Main Street is a one-and-a-half-story, three-bay, three-pile, frame private residence constructed circa 1925 in a Bungalow form. The house has a large rear addition in the shape of a Greek cross.

The main block has a side-gabled roof sheathed with asphalt shingles. An exterior brick chimney is attached onto each end wall, breaking through the overhanging eaves. A dormer occupies the bulk of the front slope of the roof; it features widely overhanging eaves supported by oversized triangular brackets, wood shingled walls, and a tripartite nine-over-one vinyl sash window. The walls of the house are brick. Fenestration is symmetrical, with eight-over-one vinyl sash windows flanking the centered entrance on the main elevation. The entrance consists of a multi-light replacement French door flanked by segmented full-height sidelights. The front porch is located below an extension of the main roof, with the eaves supported by four tapered square columns standing on brick bases connected by a low railing with square balusters. A brick set of steps leads down to the grade of the front lawn.

Character-defining elements of the dwelling include an overhang porch with square supports on brick piers and a front-gabled dormer on the front elevation.
